# Medieval Armour from Cēsis Castle

**SANDRA GARŠVIENĒ**  
**MILDA MIKALAUŠKIENĒ**  
Lithuanian Art Museum  
Pranas Gudynas Restoration Centre  
Didžioji Str. 4, LT-01128 Vilnius, Lithuania  
E-mail: restcentras@muziejus.ldm.lt

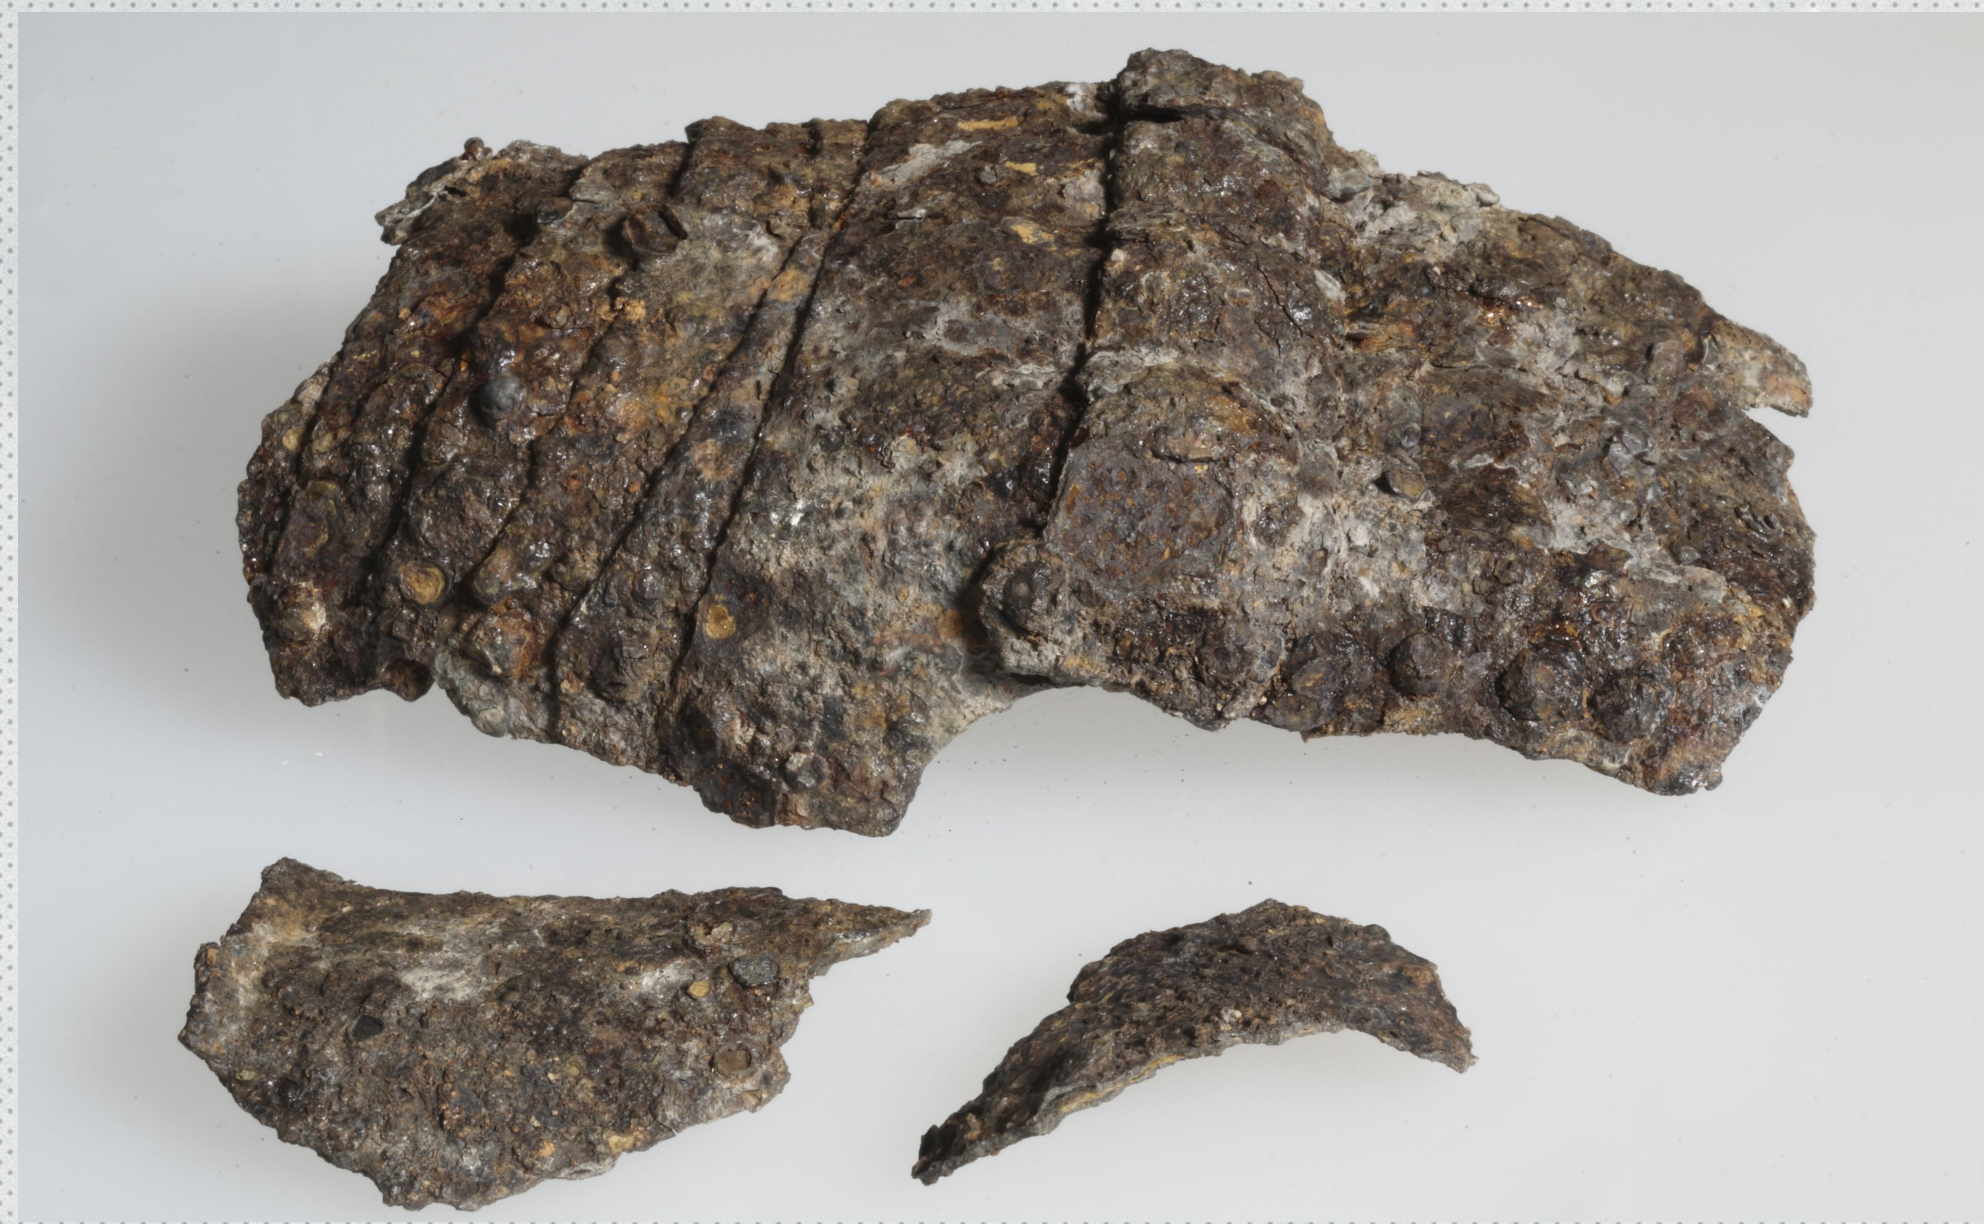
ill. 2. Gauntlet before conservation. Photo by Vilma Šileikienė.

The parts of armour were cleaned mechanically using scalpels and hand-held electric motor with a different size and roughness of grading wheels, diamond and steel grinders. The most difficult part of the time-consuming cleaning process was taking off firmly adhered concretions from the surface of the metal. The radiographs were a huge aid in finds cleaning process. After the cleaning details were treated with rust binder – 5% tannin solution in ethanol. Very fragile details firstly were treated with tannin solution, consolidated and after that cleaned mechanically. The pieces of armour were dried with acetone and kept

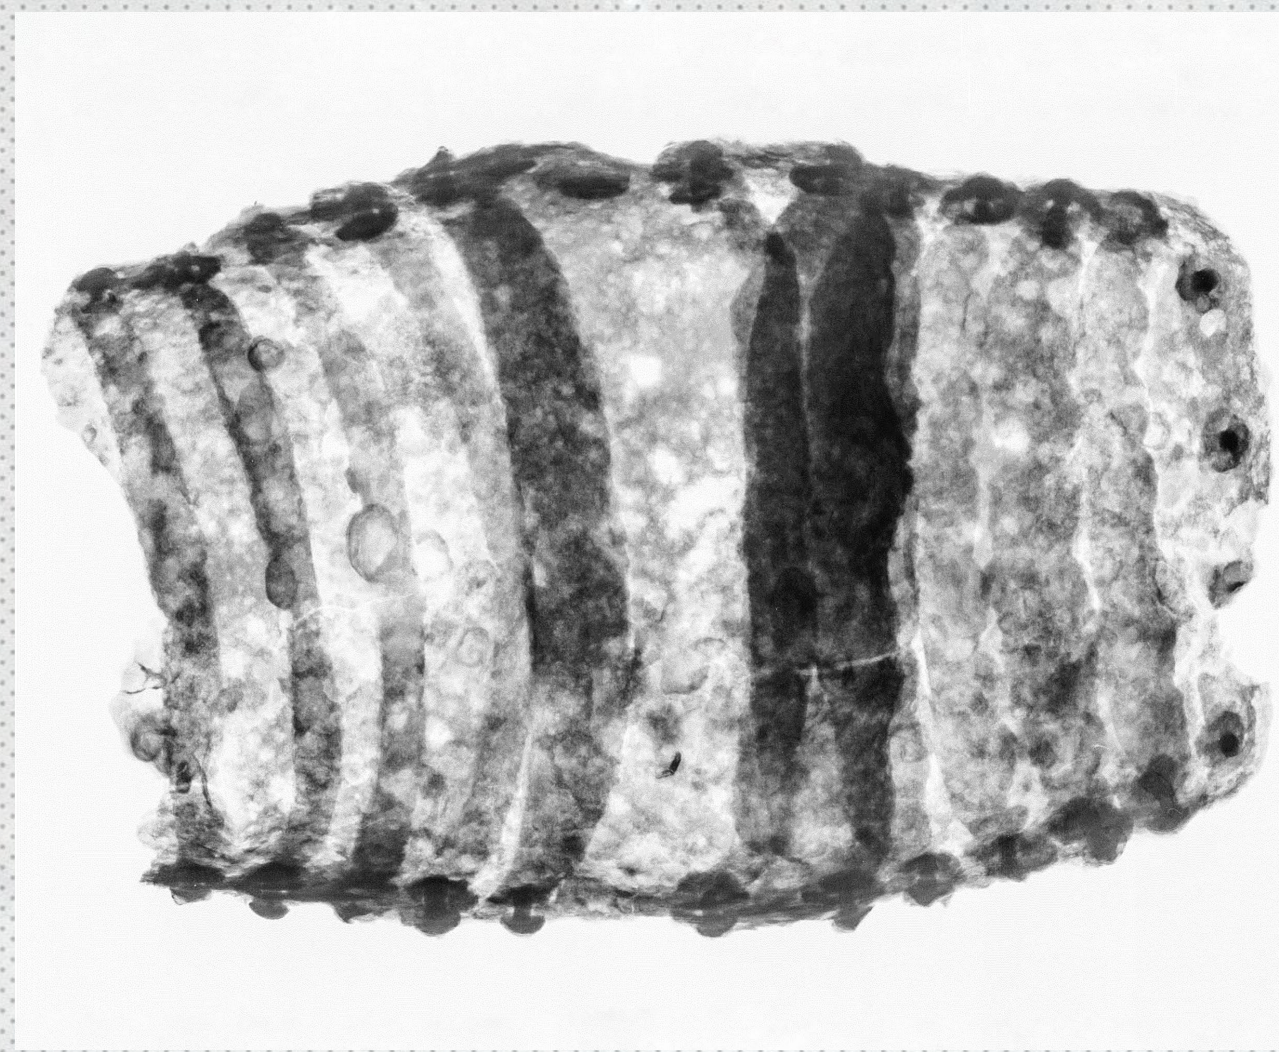
The mostly corroded elements of armour were brought to P. Gudynas Centre for Restoration and were conserved here from 2013 till now. Before conservation radiographs of all finds were made in order to evaluate the state of metal. The radiographs showed that the core of iron of all finds is heavily corroded except some areas; metal is porous and fragile, some of the finds are fragmented.

ill. 3. Radiograph of the gauntlet. Photo by Tomas Ručys.

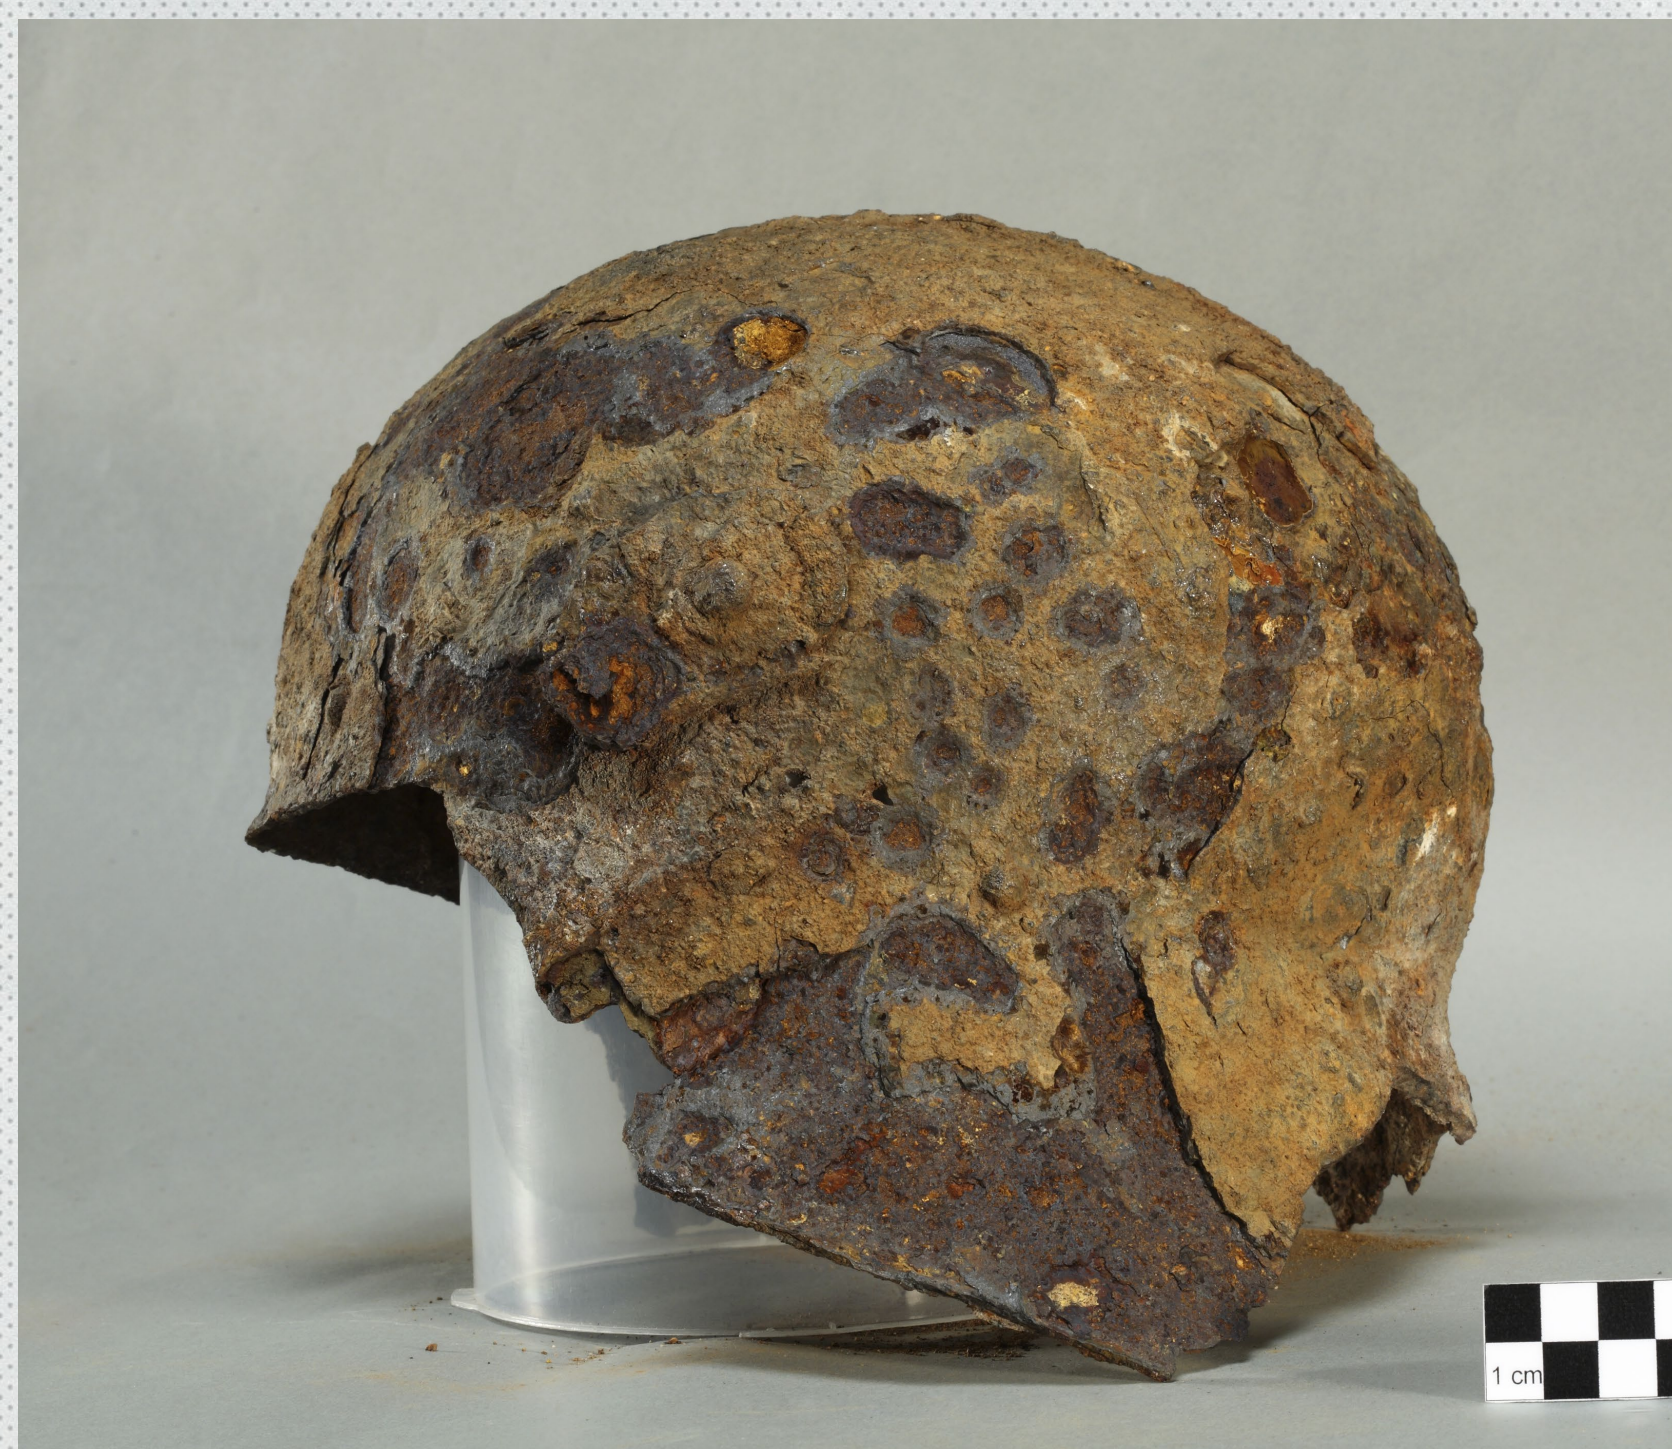
ill. 4. Sallet without back part before restoration. Photo by Vilma Šileikienė.

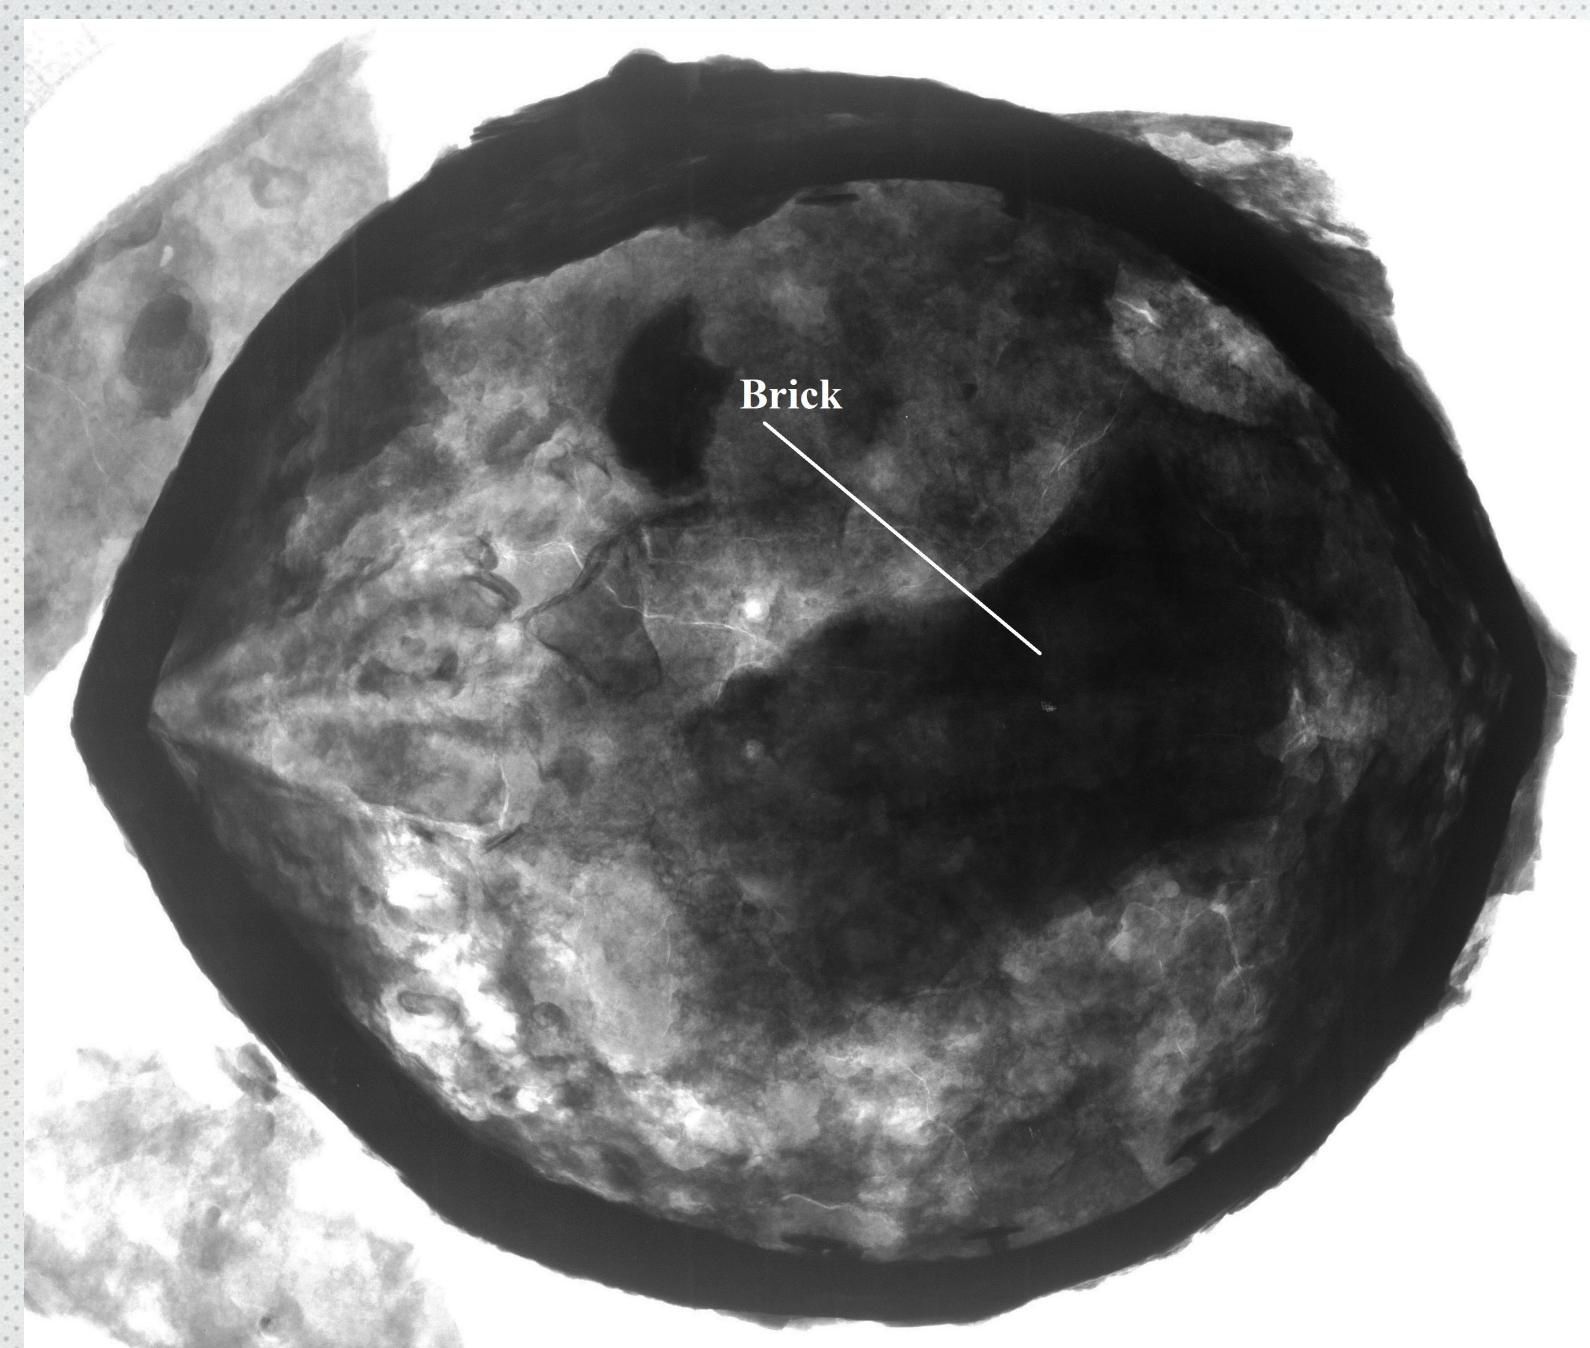
ill. 5. Radiograph of the sallet without back part. Photo by Tomáš Giližetdinov.
