Scientific Research and Restoration of Artwork “Immaculate Conception of the Blessed Virgin Mary” Painted by Unknown 17th (?) Century Lithuanian Artist

INGA PETKUTYTĖ

Lithuanian Art Museum
Pranas Gudynas Restoration Centre
Didžioji Str. 4, LT-01128 Vilnius, Lithuania
E-mail: restcentras@muziejus.ldm.lt

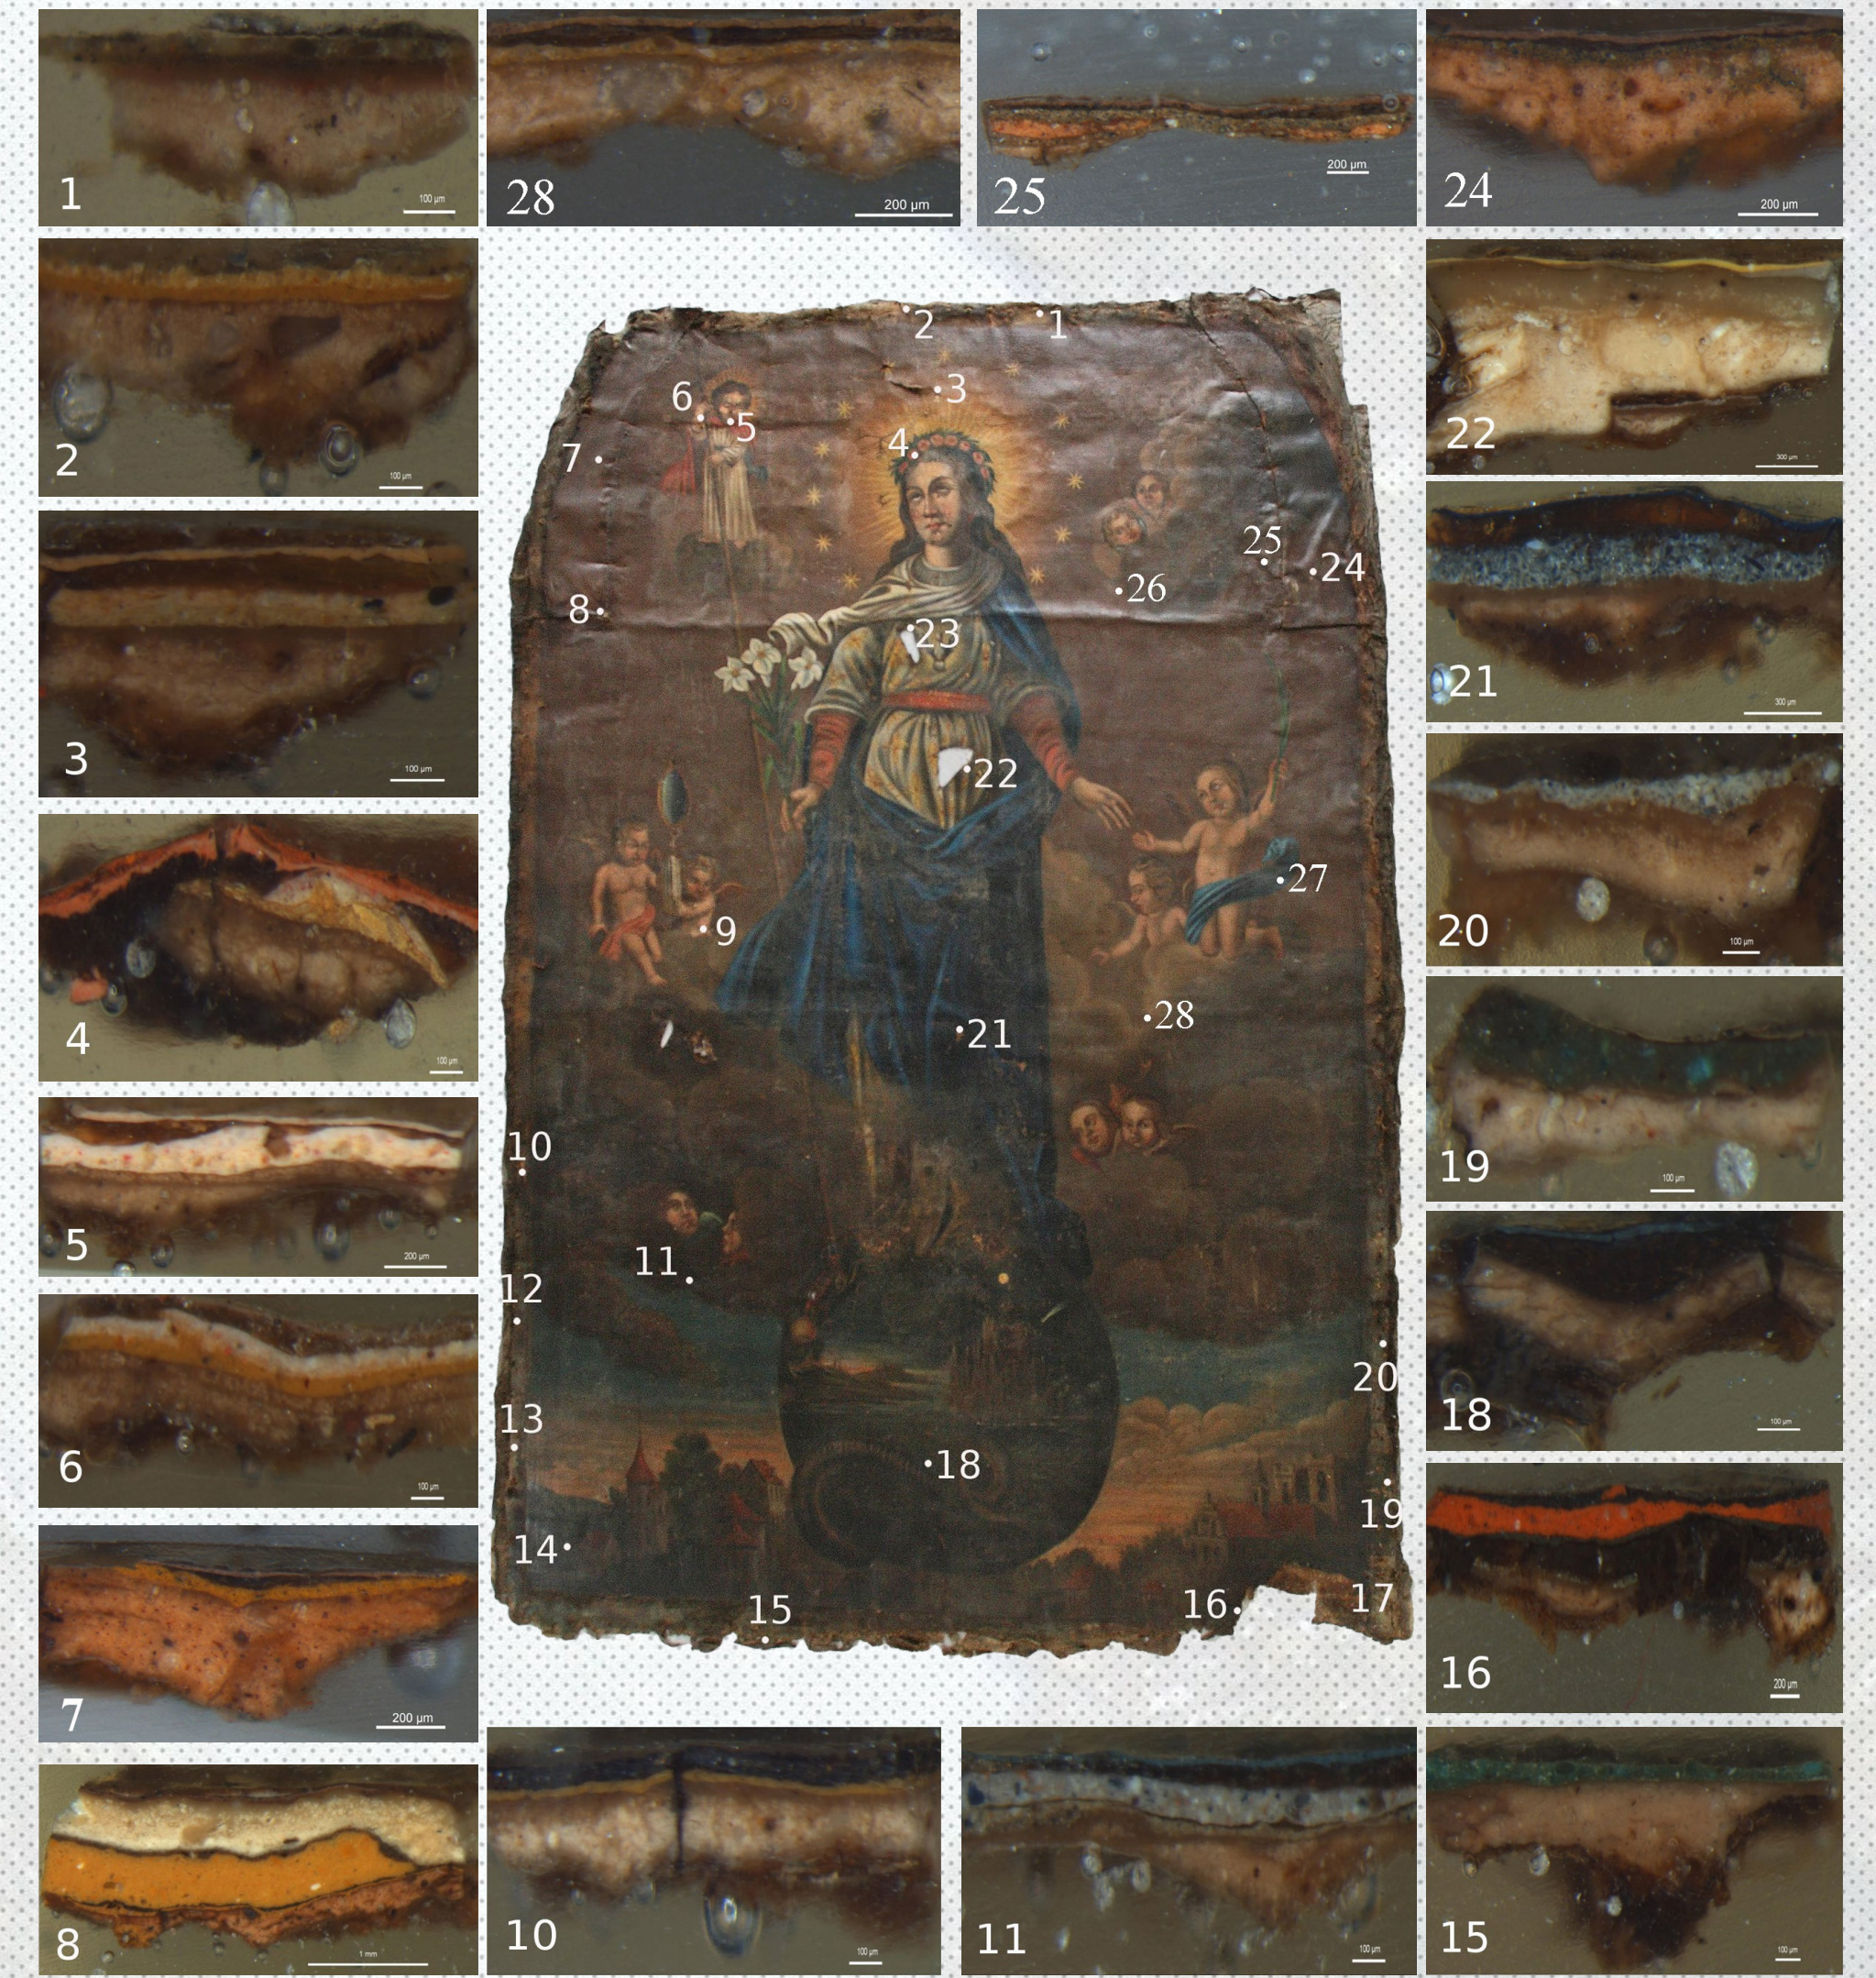
The microchemical, stratigraphic and physical tests research results revealed in detail painting's structure and restoration materials used previously.

ill. 5. Cross sections of the paint layers.

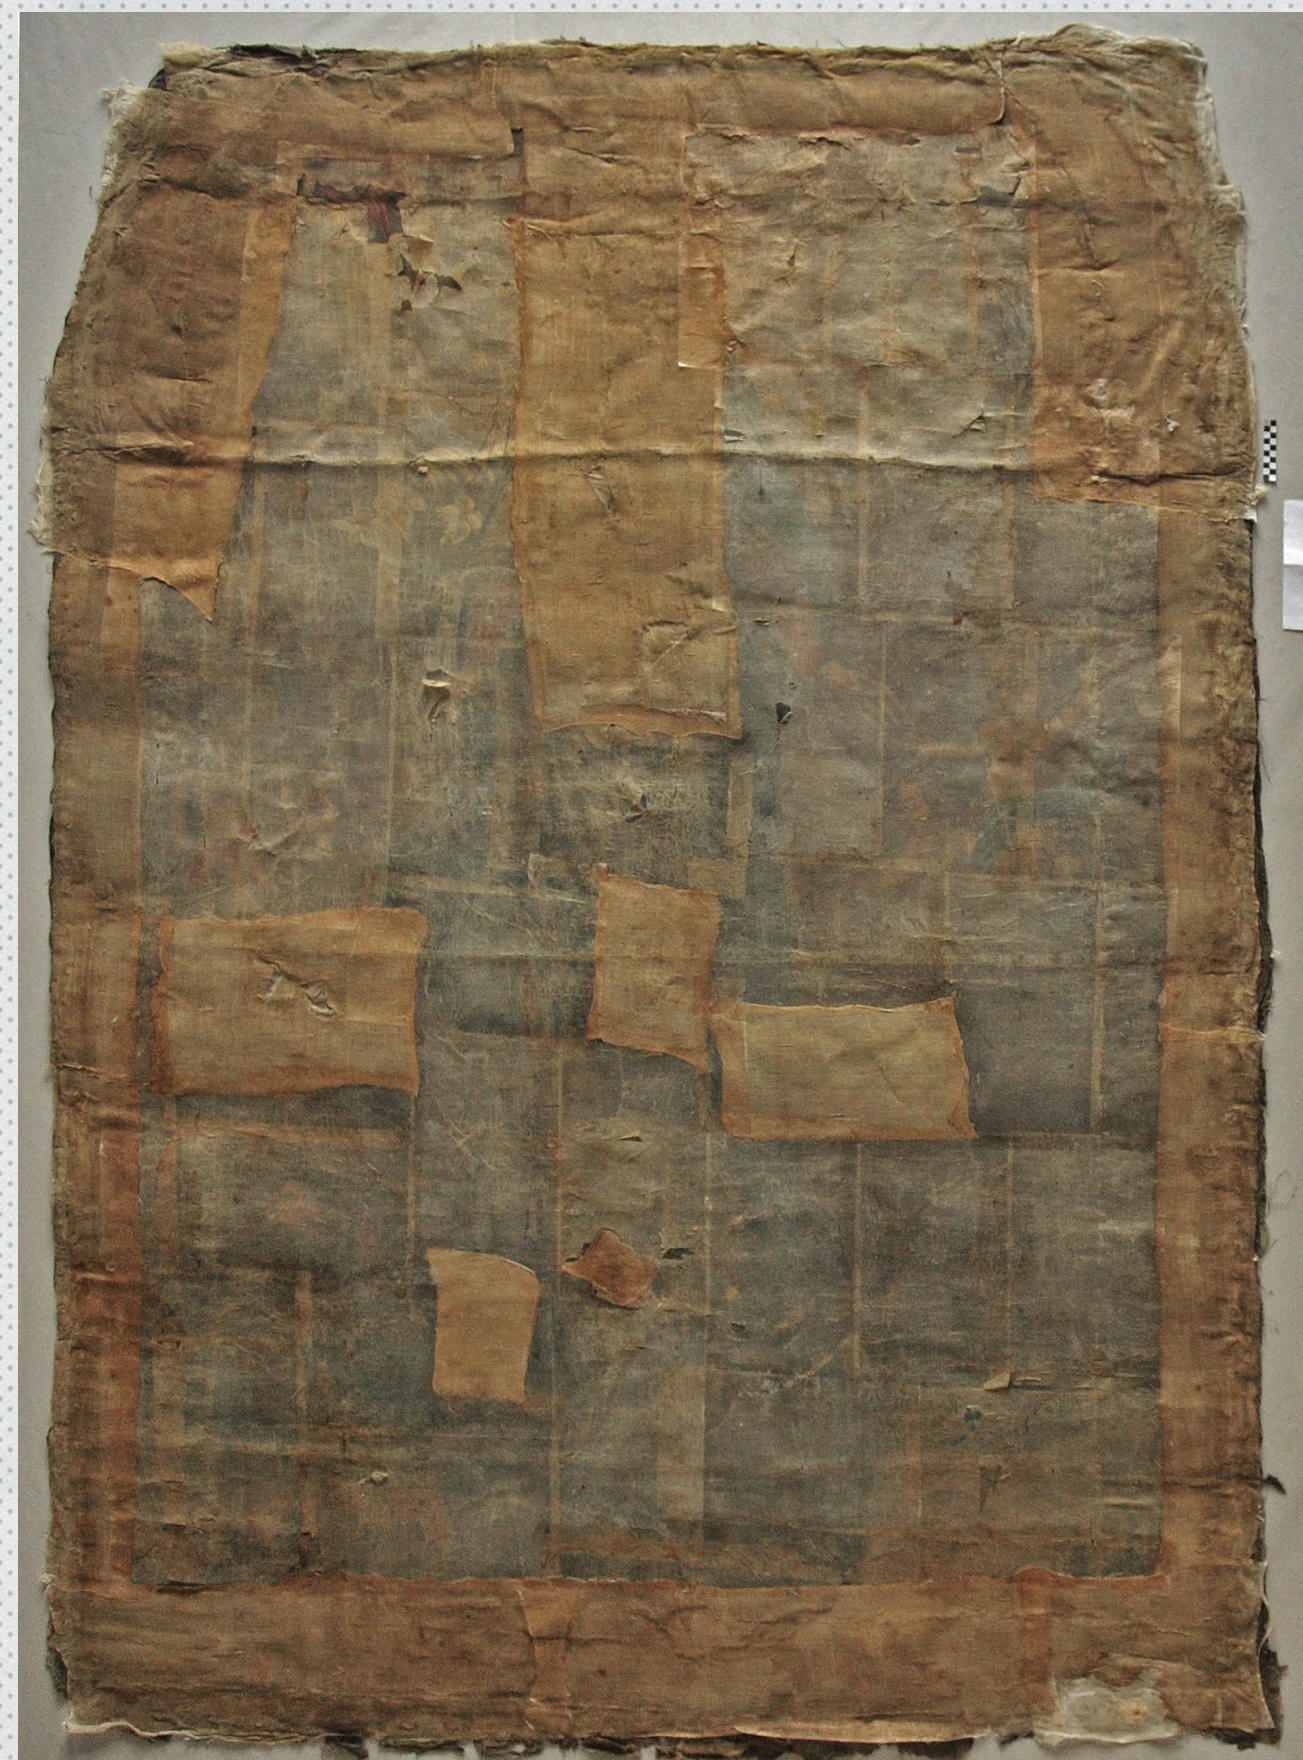
ill. 1. Before the restoration, visual side with an old preventive tissue paper and gauze.

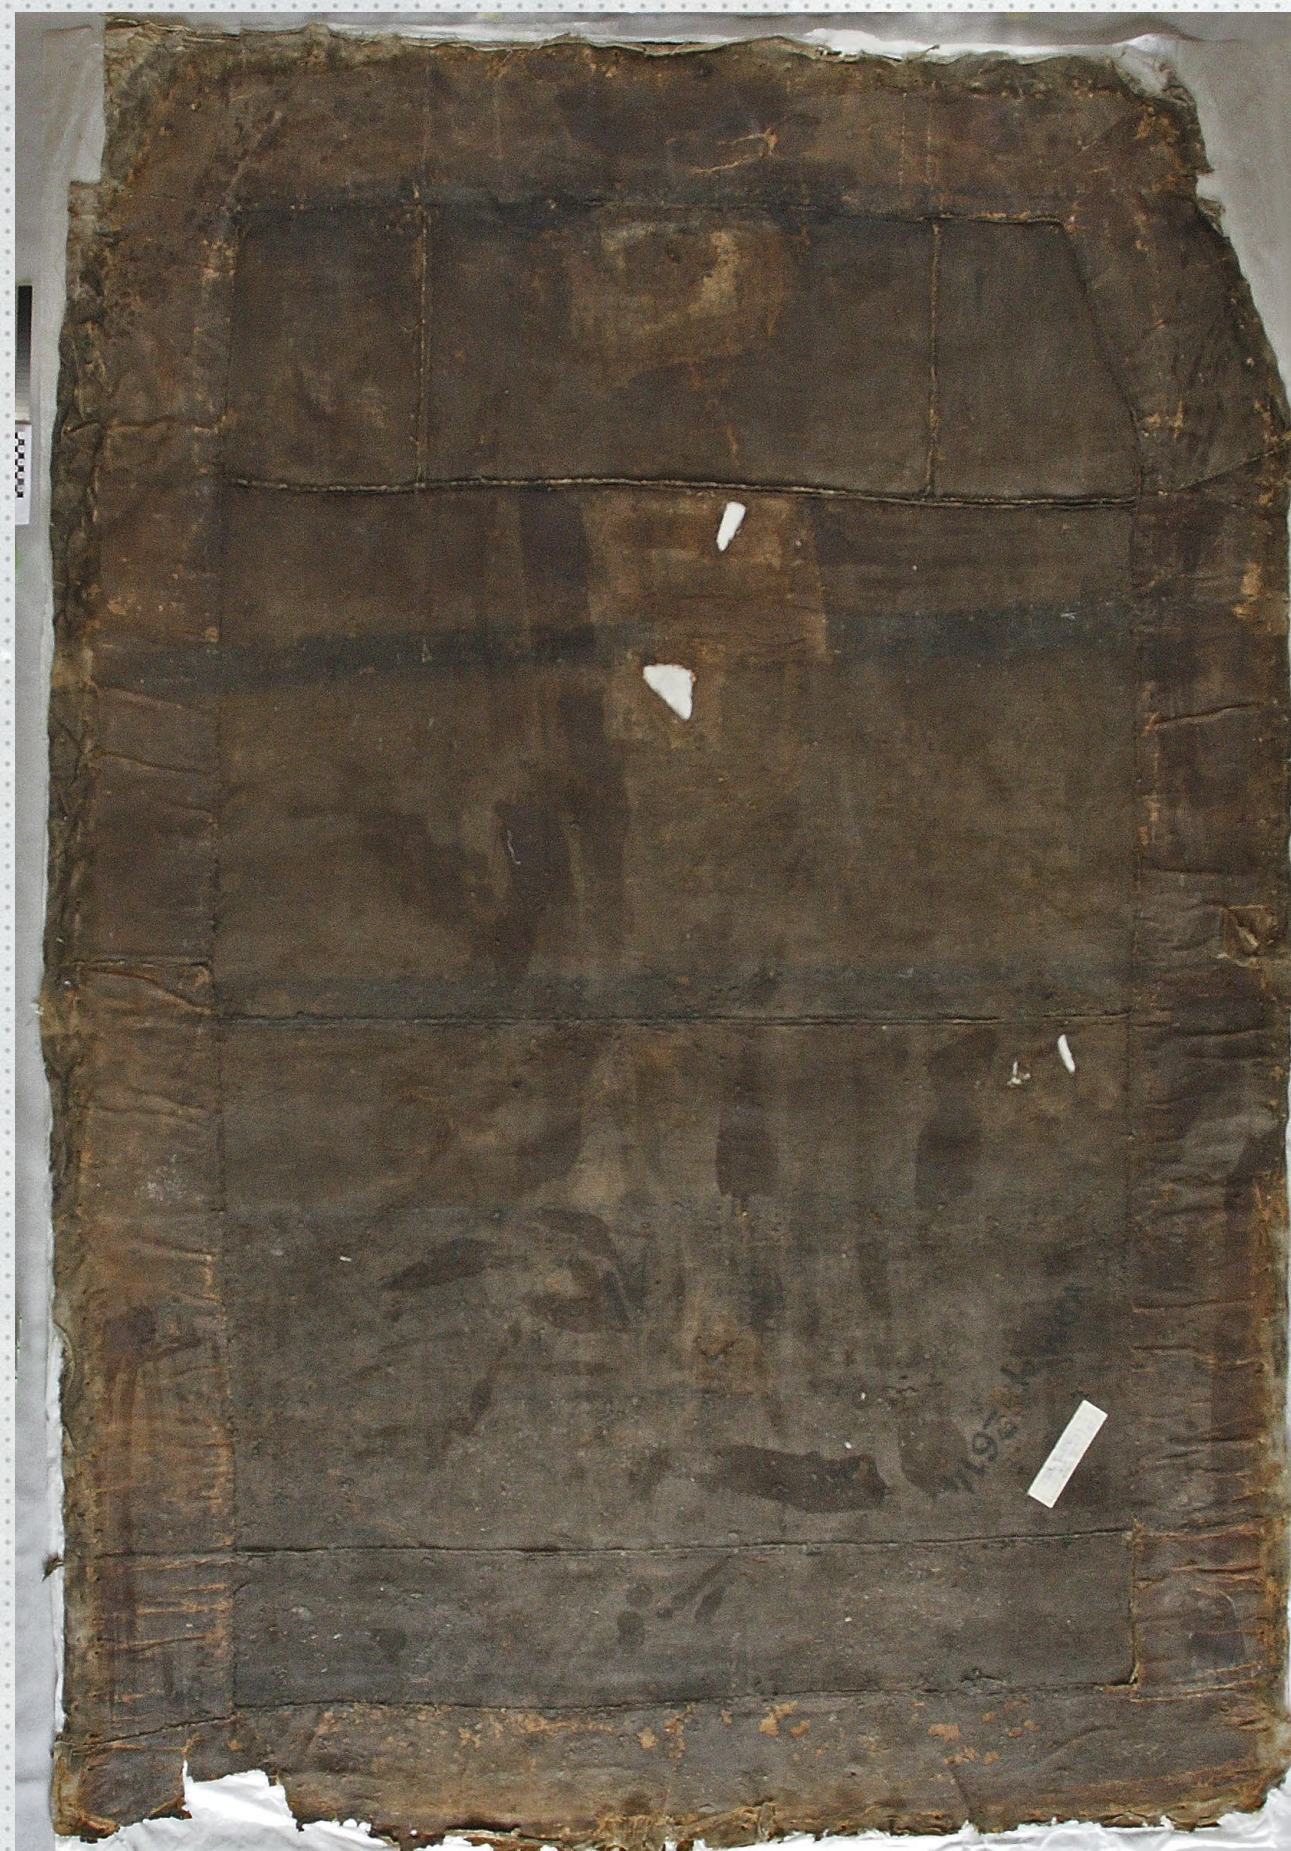
Painting's basis from backside side during previous restorations was brushed with thick mass impregnation layer, in the same manner few patches were made. The edges of the painting strengthened gluing and bonding through linen bands. During previous restorations the paintings size changed, semicircular upper edge part

ill. 2. Backside of the painting before restoration.

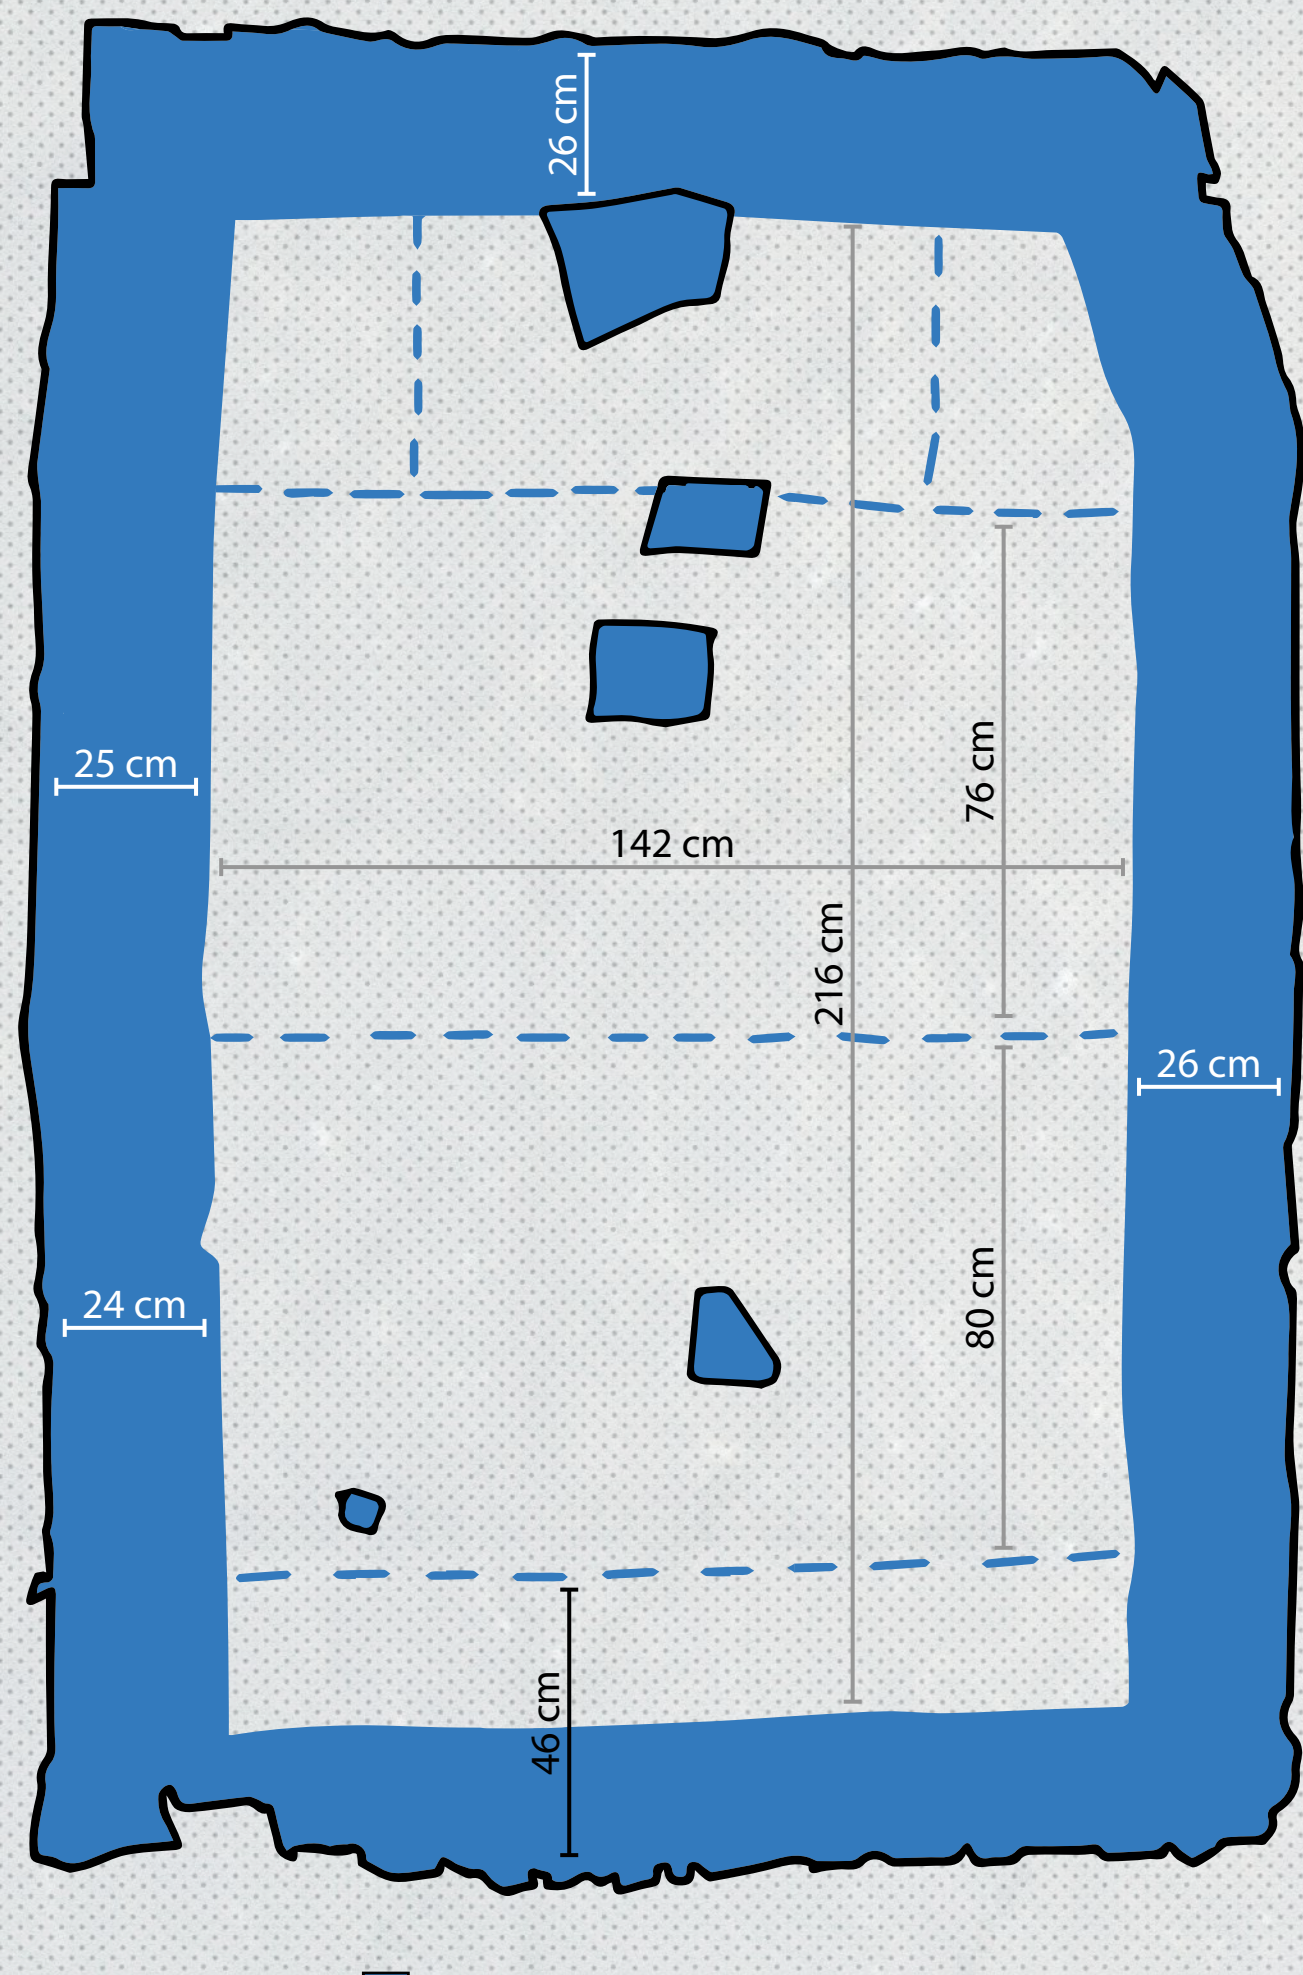
ill. 3. Scheme of defects of the backside.

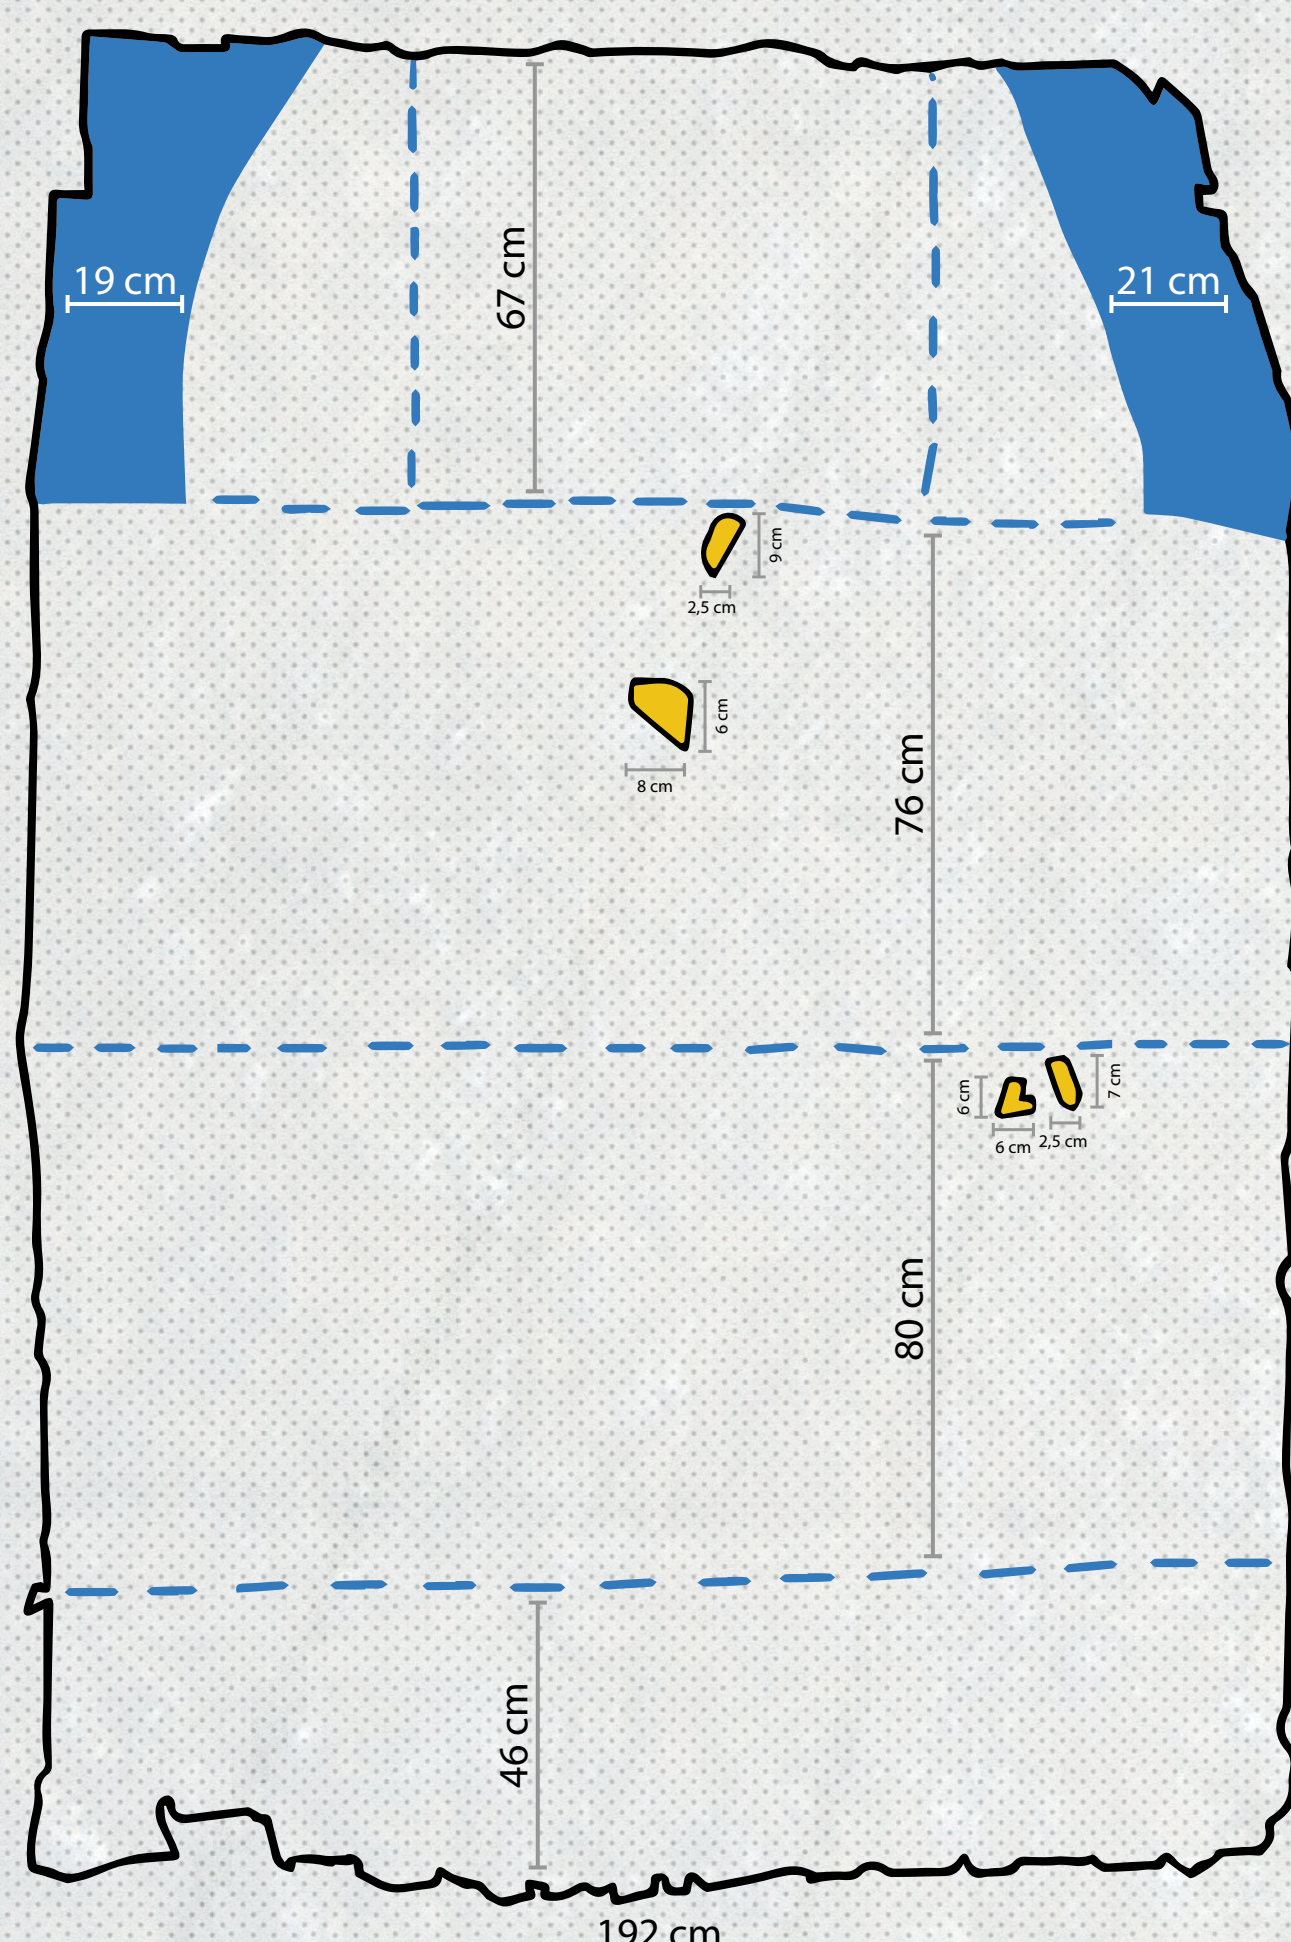
ill. 4. Scheme of defects of the backside: the painting's format is changed during previous restorations.

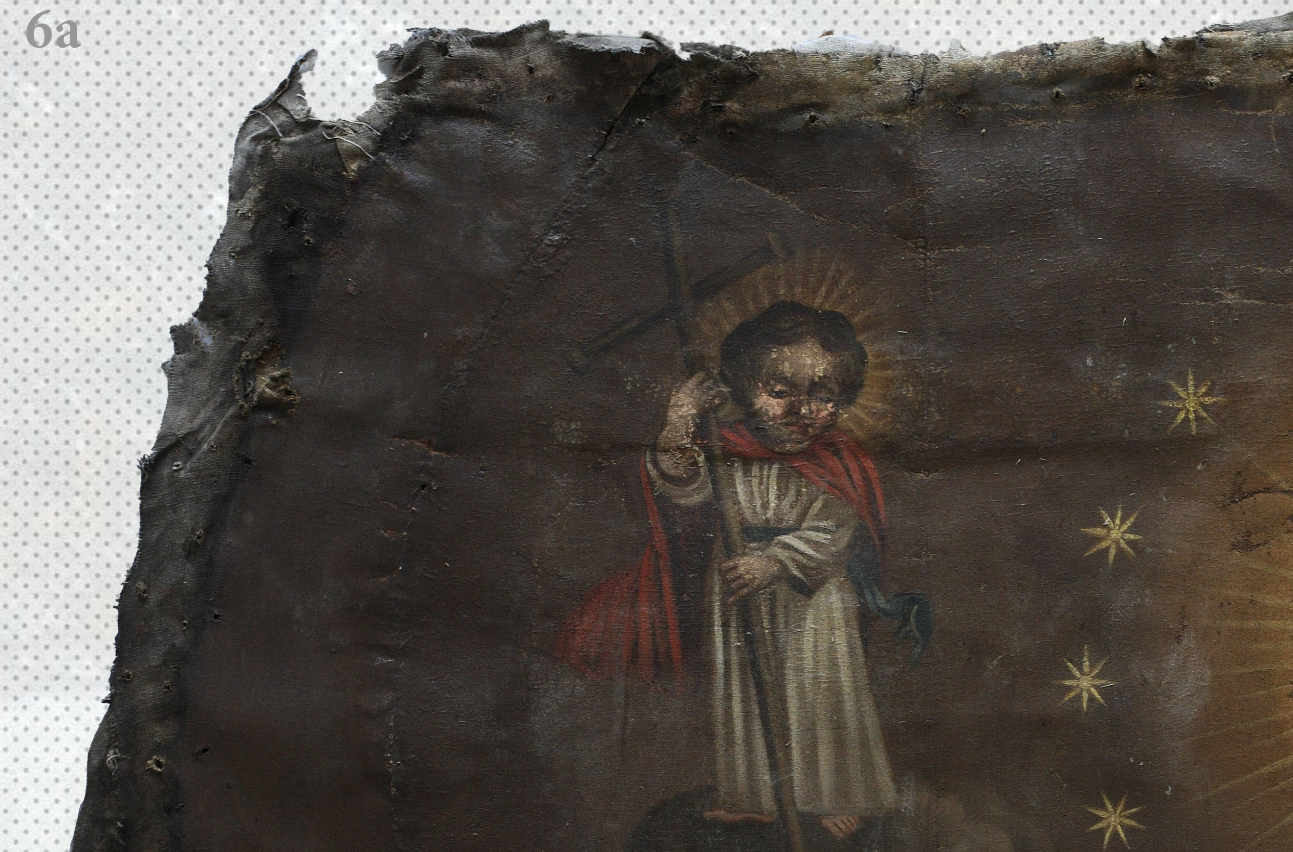
ill. 6. a), b) Removal of the non-authentic fragment of canvas on the top of the painting.

Tissue paper and gauze on the visual side of the picture from previous restorations were removed. The painting's format changes rectified – removed the sewn canvas fragments. Canvas patches on backside from previous restorations and a very thick and hard layer of impregnating mass removed. Restored authentic canvas losses, reconstructed genuine painting's format. Consolidated paint and ground layers, leveled and flattened basis. The artwork lined onto a new canvas. Painting stretched on a new stretcher. Paint and primer losses were primed. Old varnish on the visual side of the painting recovered. Even though after previous restorations the whole area was repainted at least twice the X-Ray image show that painting's composition was changed only slightly. Restorers removed overpainted areas layer by layer and exposed well-preserved seventeenth century authentic painting. On Earth depicted in painting, was found written restoration year, and after the founding this area was decided not to touch. Newly primed areas we retouched with watercolors. In places of biggest losses – at the top and bottom of the painting – reconstruction of drawings was made. The painting covered with protective layer of dammar varnish.

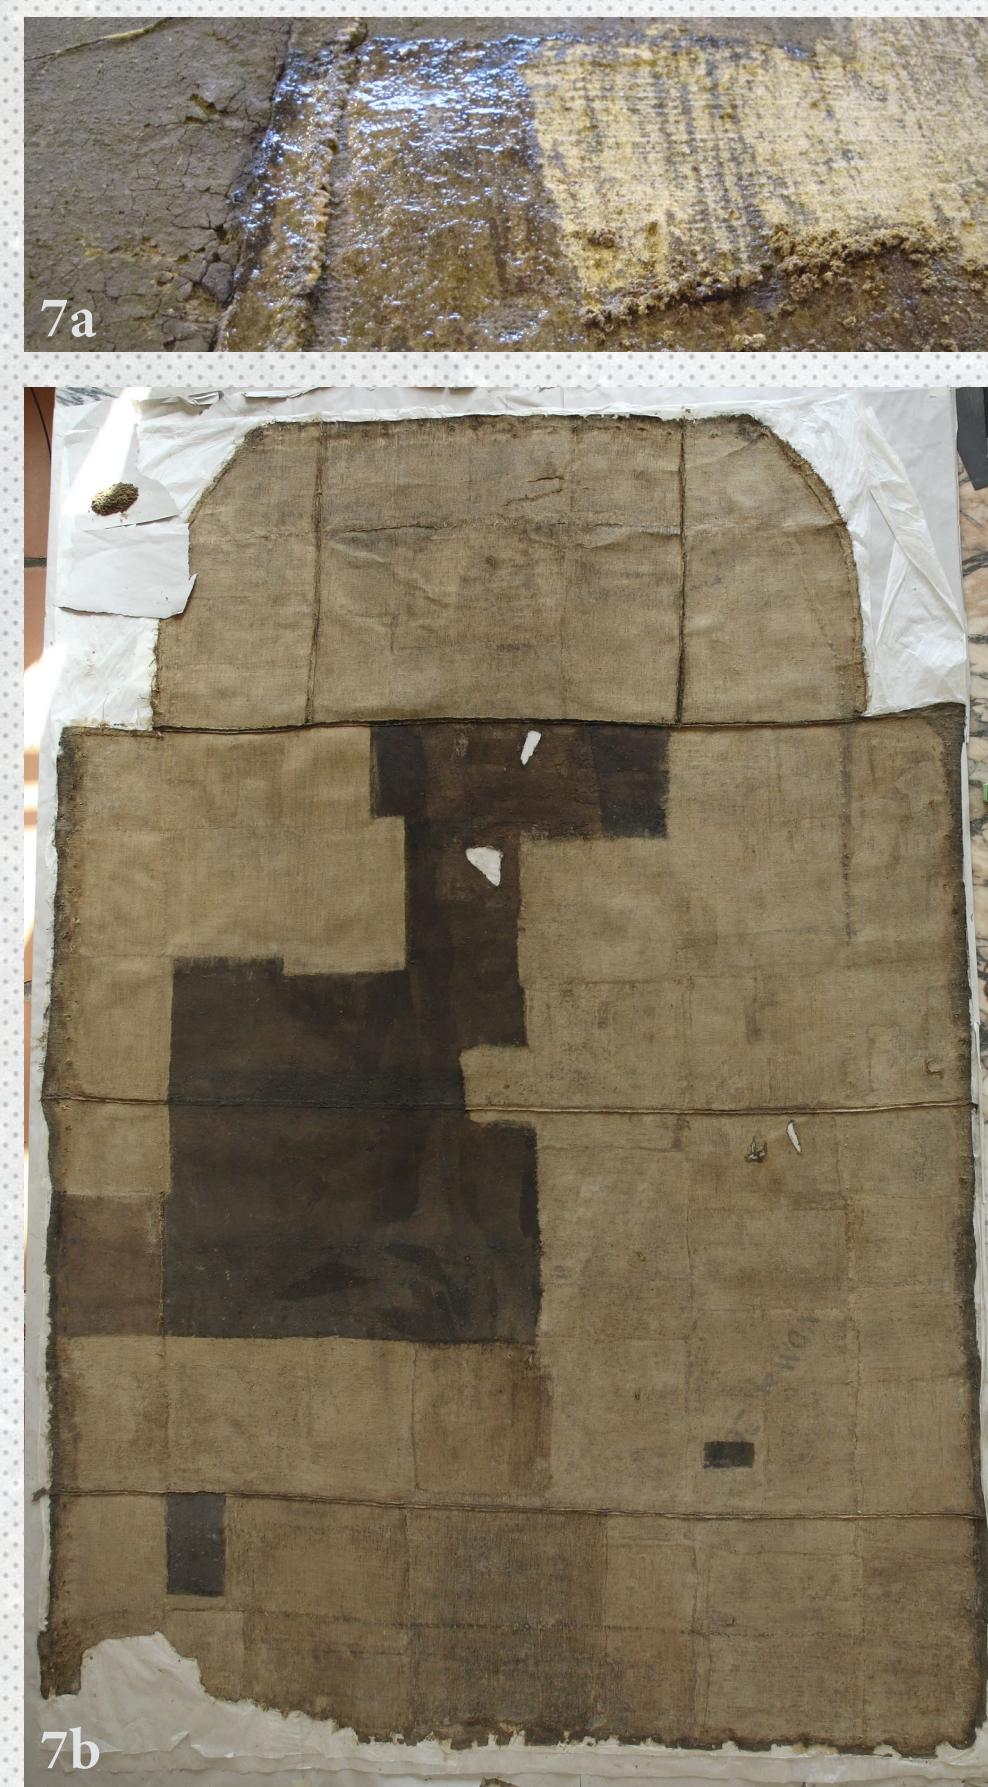
ill. 7. a), b) Thinning of an old layer of impregnating mass on backside.

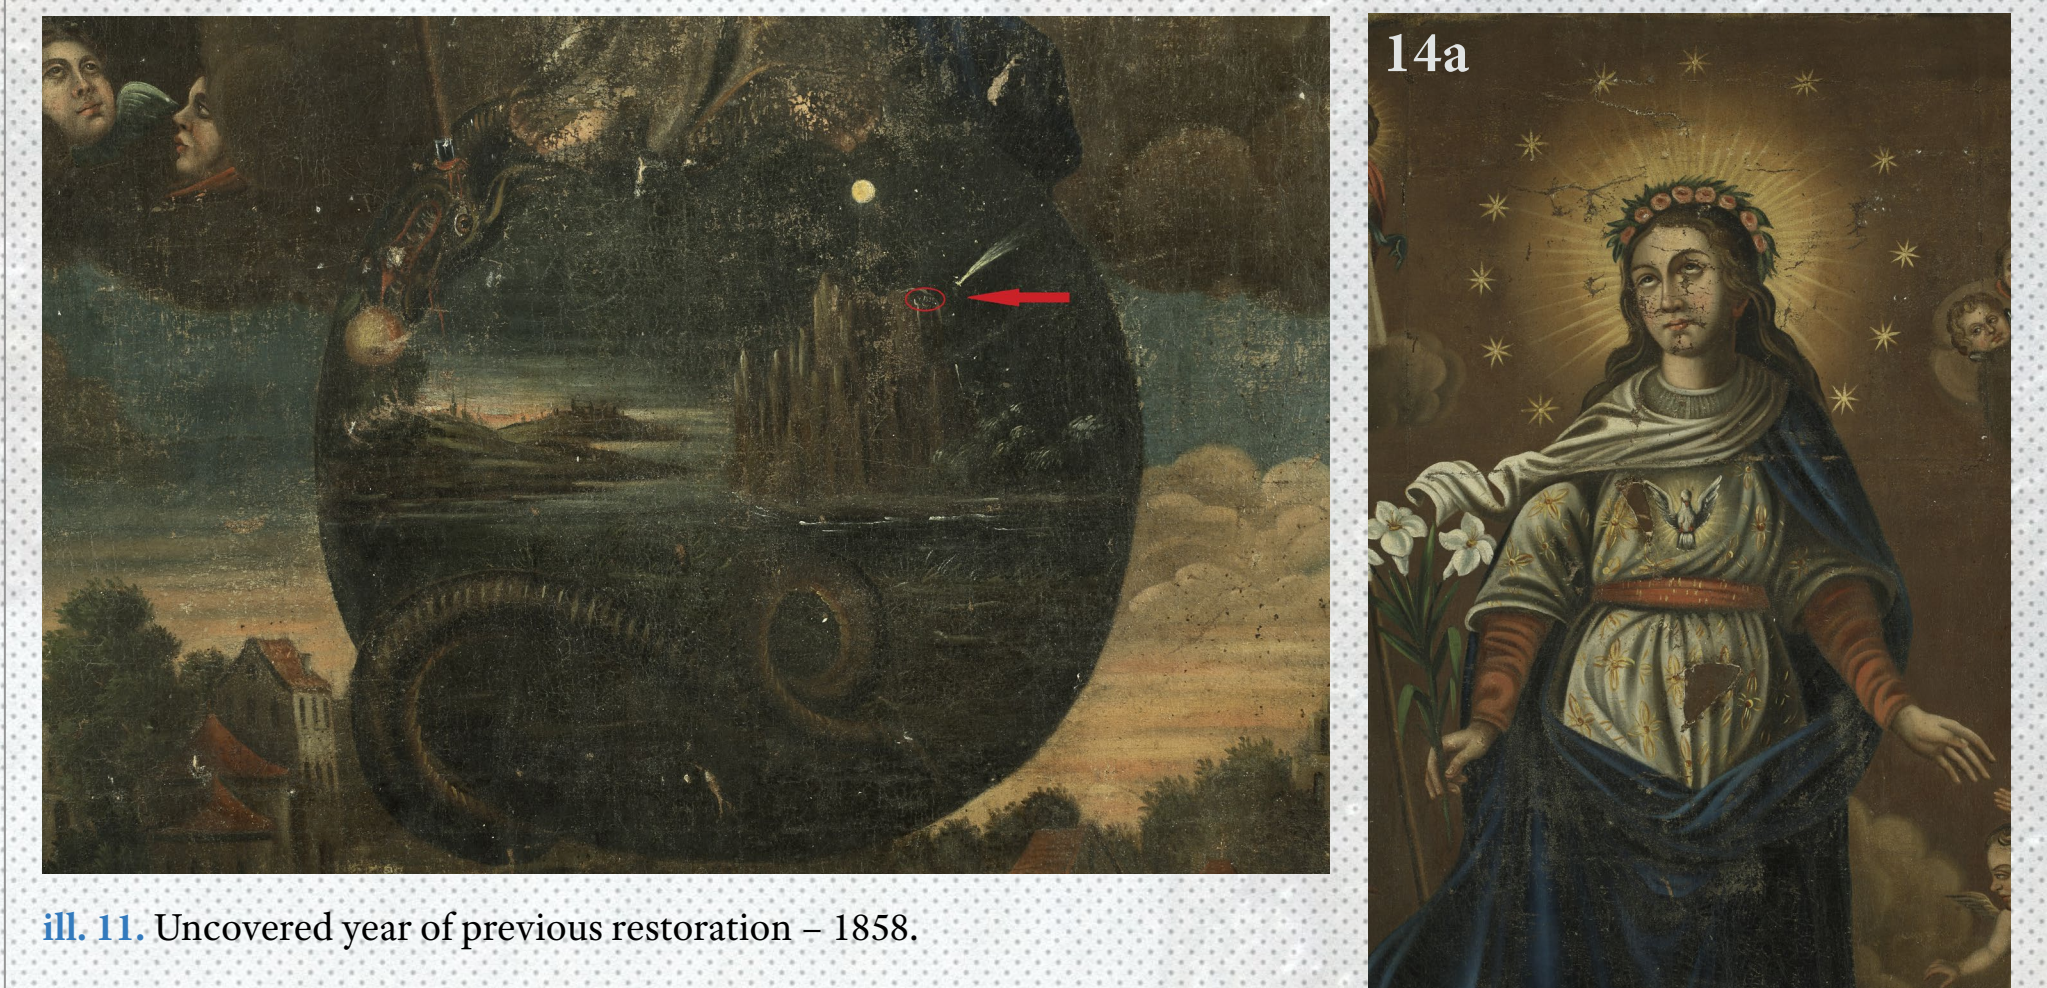
ill. 11. Uncovered year of previous restoration – 1858.

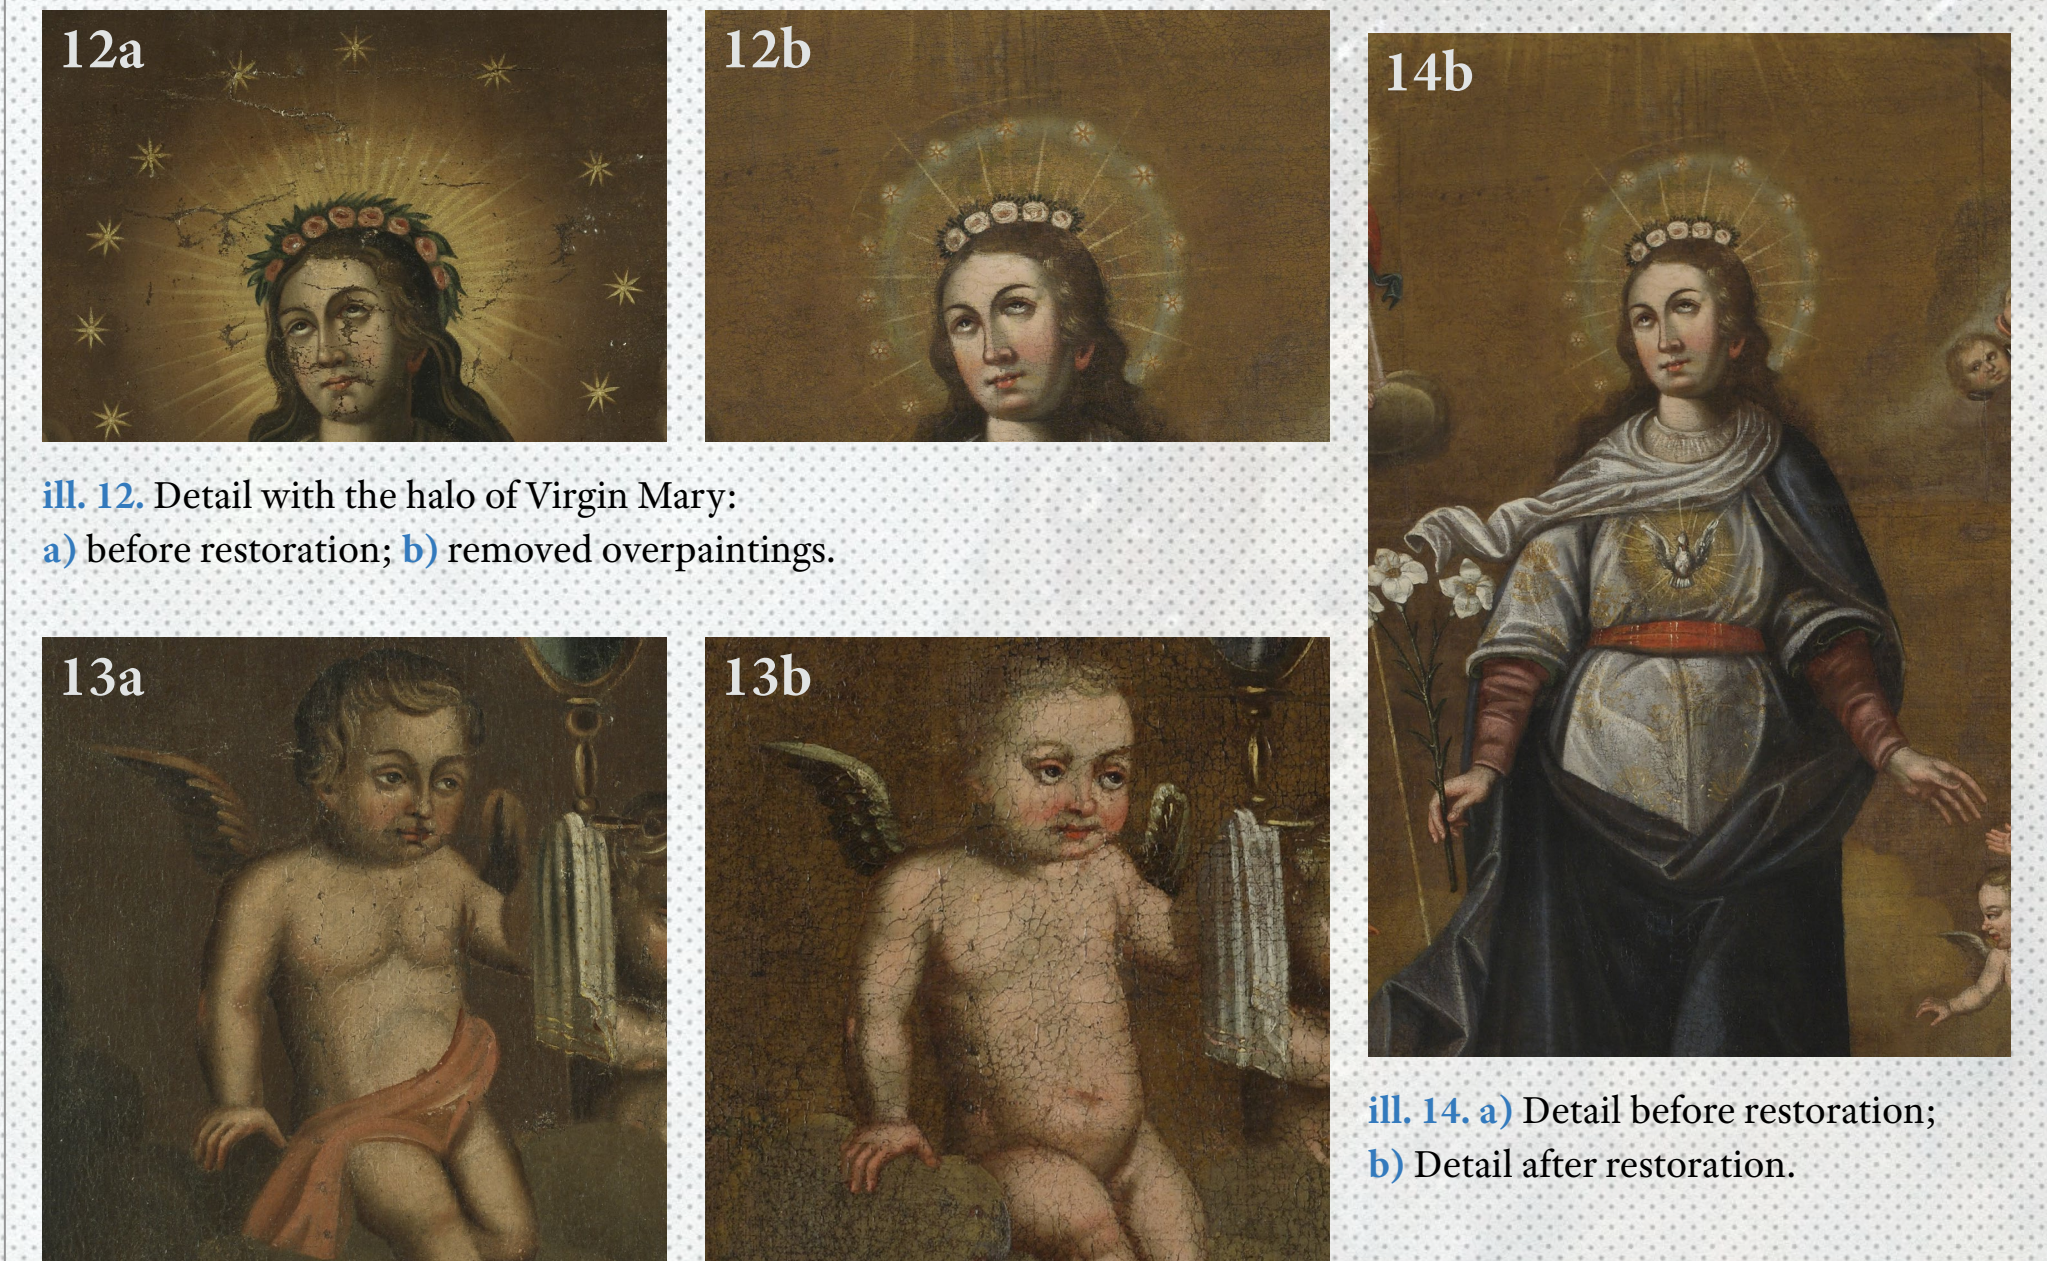
ill. 12. Detail with the halo of Virgin Mary: a) before restoration; b) removed overpaintings.

ill. 13. Detail of an angel with drapery on the left side: a) before restoration; b) removed overpaintings.

ill. 14. a) Detail before restoration; b) Detail after restoration.
