Scientific Research and Restoration of Artwork “Immaculate Conception of the Blessed Virgin Mary” Painted by Unknown 17th (?) Century Lithuanian Artist

INGA PETKUTYTĖ

Lithuanian Art Museum
Pranas Gudynas Restoration Centre
Didžioji Str. 4, LT-01128 Vilnius, Lithuania
E-mail: restcentras@muziejus.ldm.lt

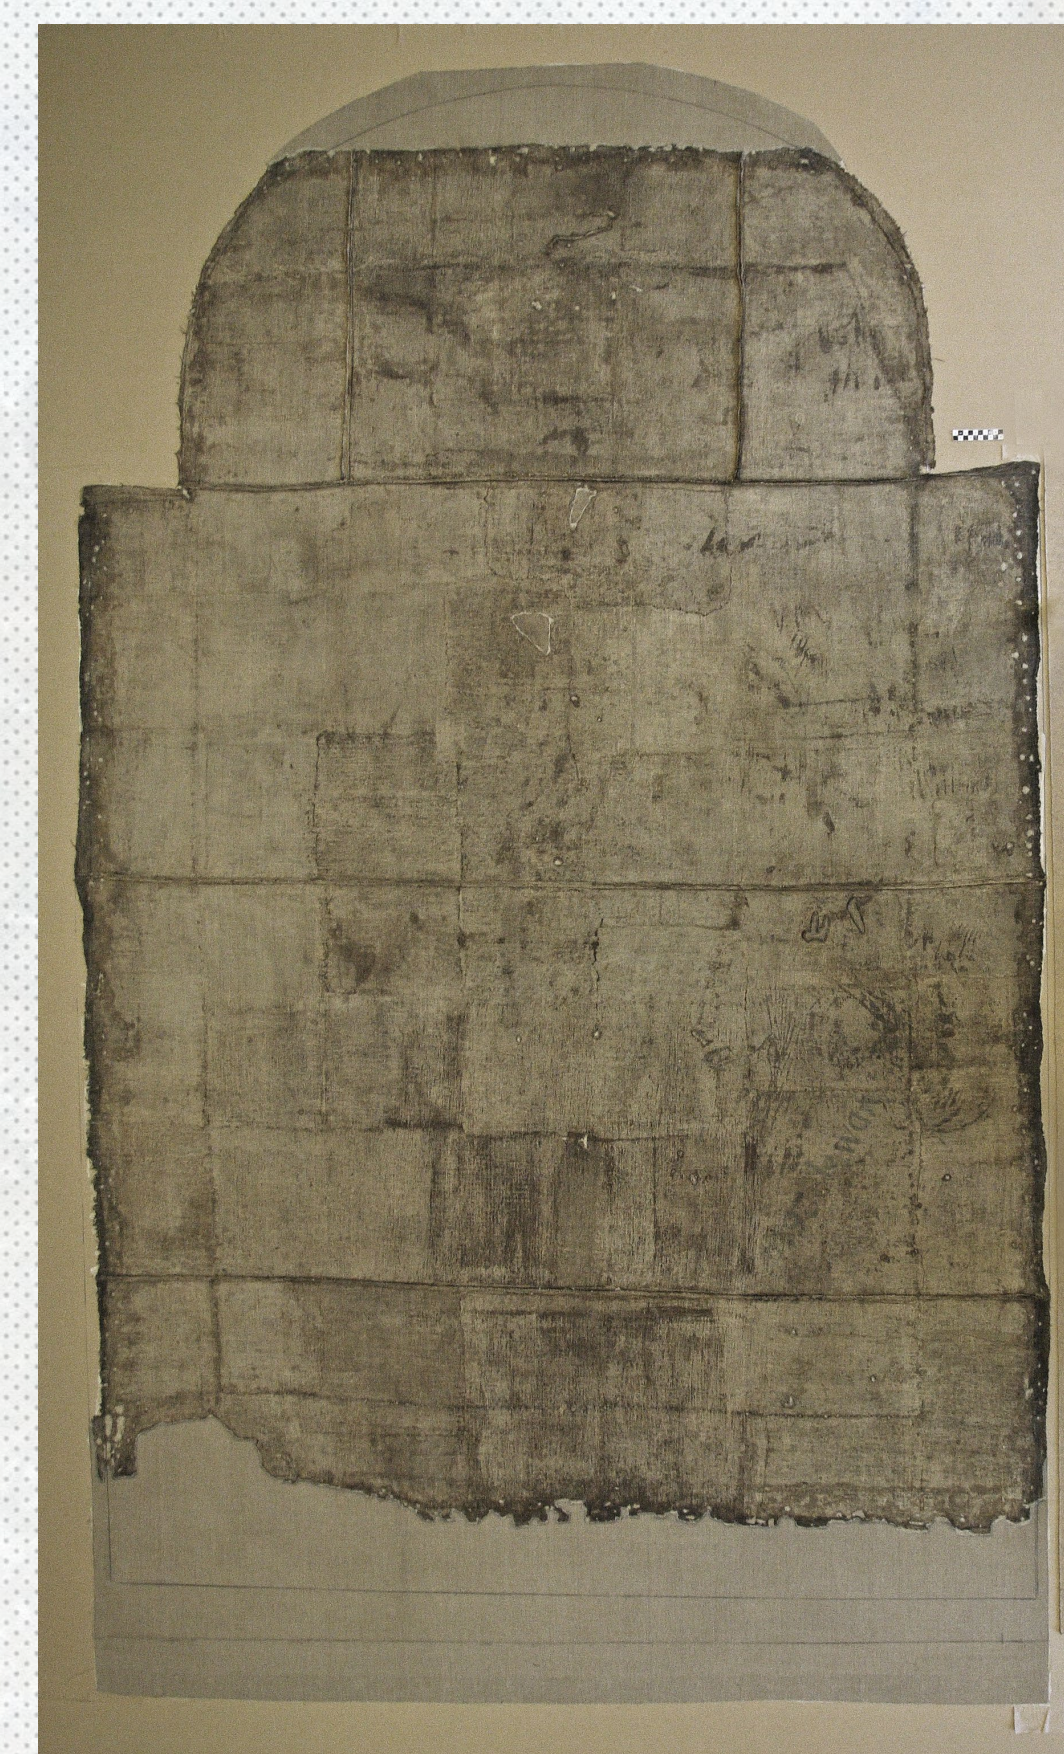
ill. 8. Reconstructing an authentic format of the painting.

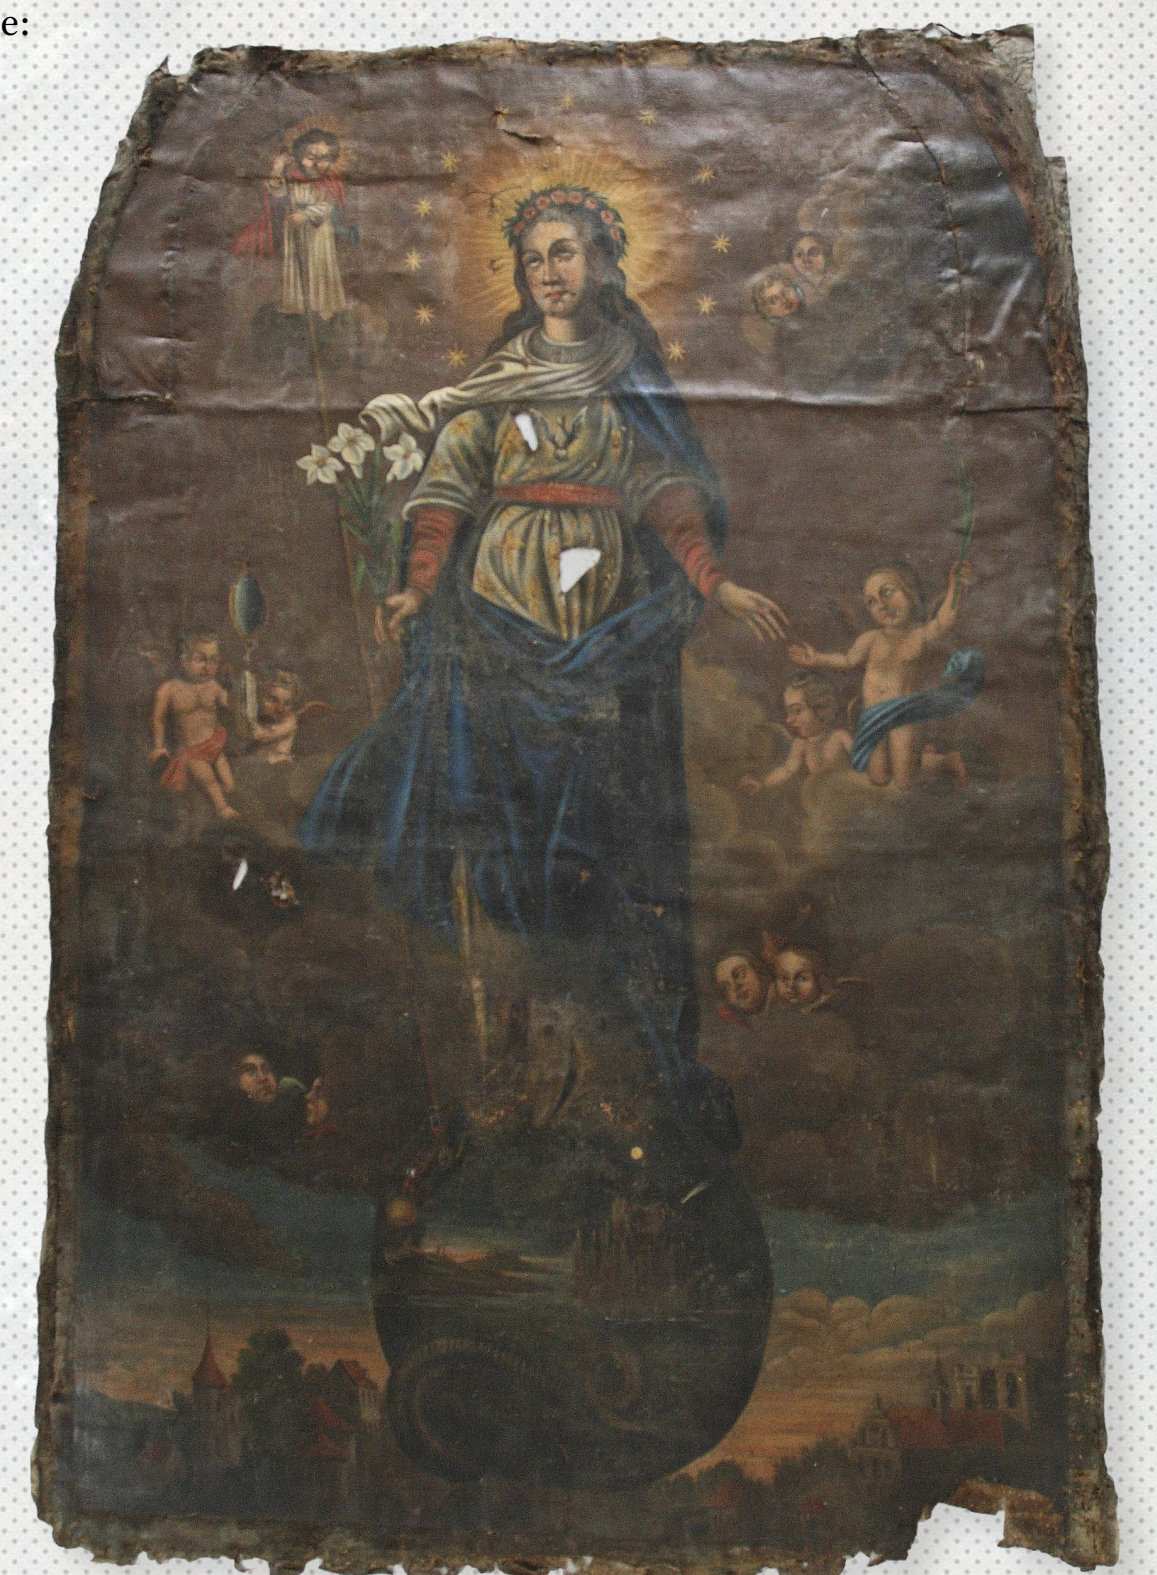
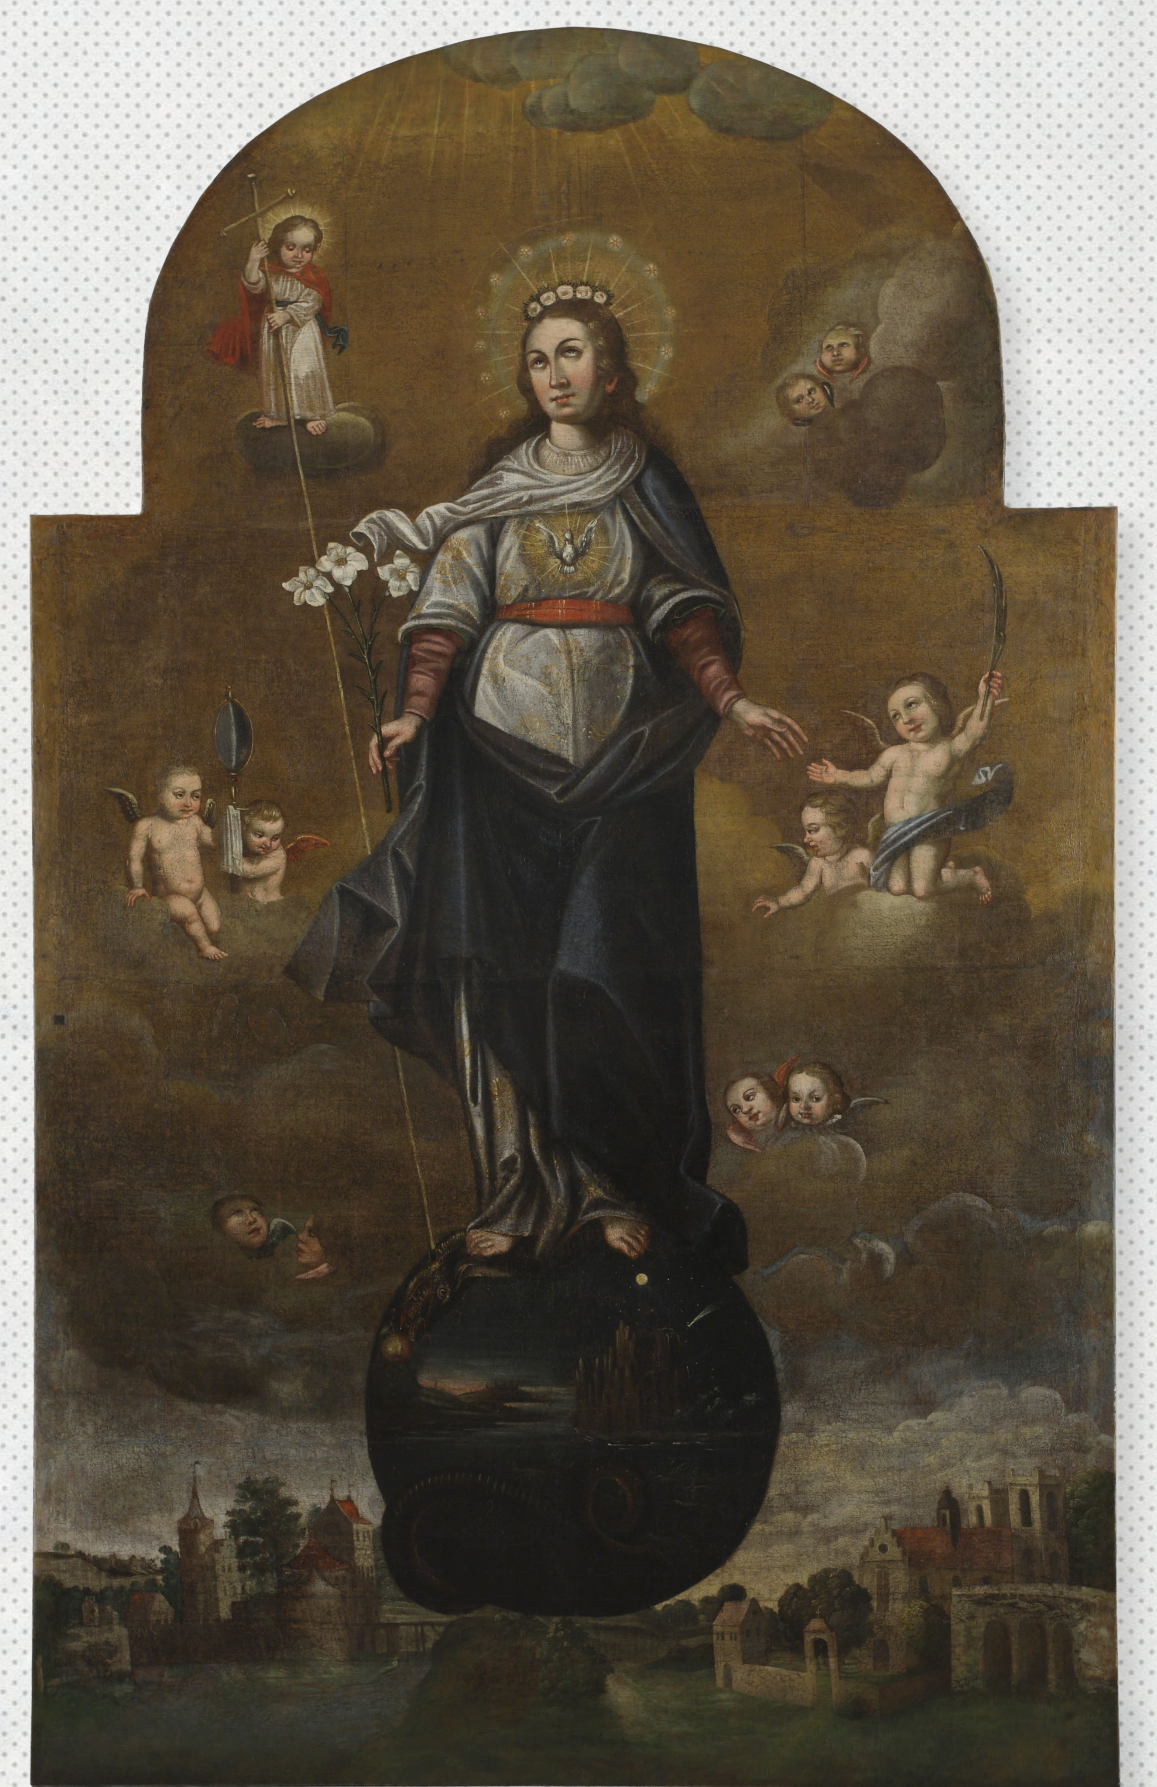
ill. 15. a) Painting before restoration. b) Painting after restoration.

Tissue paper and gauze on the visual side of the picture from previous restorations were removed. The painting's format changes rectified – removed the sewn canvas fragments. Canvas patches on backside from previous restorations and a very thick and hard layer of impregnating mass removed. Restored authentic canvas losses, reconstructed genuine painting's format. Consolidated paint and ground layers, leveled and flattened basis. The artwork lined onto a new canvas. Painting stretched on a new stretcher. Paint and primer losses were primed. Old varnish on the visual side of the painting recovered. Even though after previous restorations the whole area was repainted at least twice the X-Ray image show that painting's composition was changed only slightly. Restorers removed overpainted areas layer by layer and exposed well-preserved seventeenth century authentic painting. On Earth depicted in painting, was found written restoration year, and after the founding this area was decided not to touch. Newly primed areas we retouched with watercolors. In places of biggest losses – at the top and bottom of the painting – reconstruction of drawings was made. The painting covered with protective layer of dammar varnish.
